AUSTRALIAN WAR MEMORIAL

NEW SOUTHERN ENTRANCE REDEVELOPMENT PROJECT

FEASIBILITY REPORT ON DISMANTLING AND REUSE OF EXISTING STONE ELEMENTS

20 February 2020

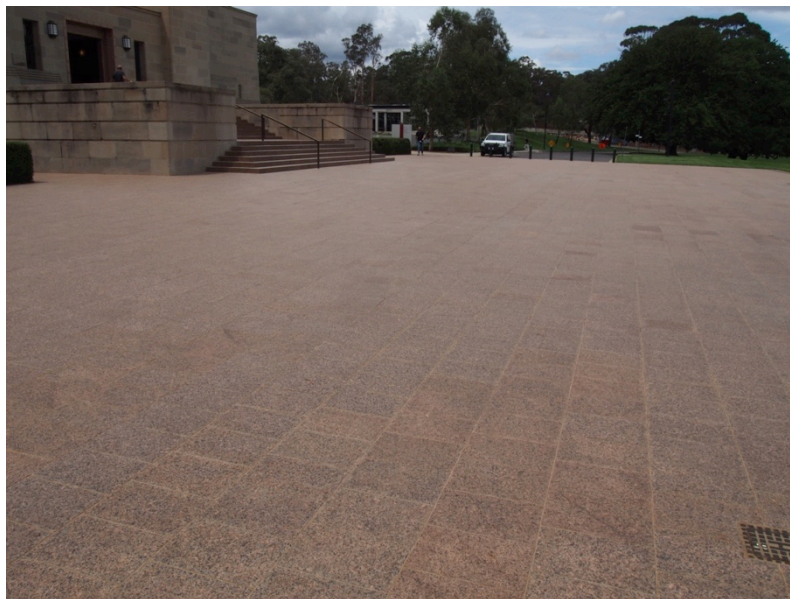
Figure 1 Granite paving to the forecourt. (Photo: Jasper Swann, 12 February 2020)

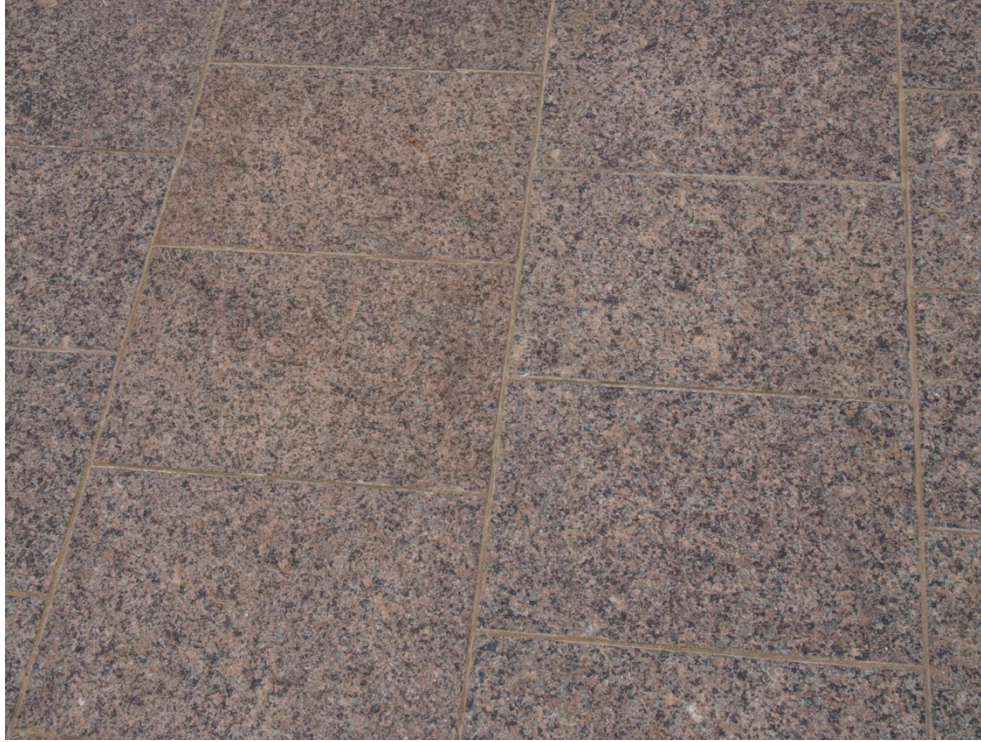
The existing paving to the forecourt consists of 450mm x 300mm 'Christmas Bush' granite pavers, (Fig.2). The thickness of the pavers is understood, from previous internal AWM investigation, to be 65mm.

Figure 2 450mm x 300mm granite pavers to forecourt. (Photo: Jasper Swann, 12 February 2020)

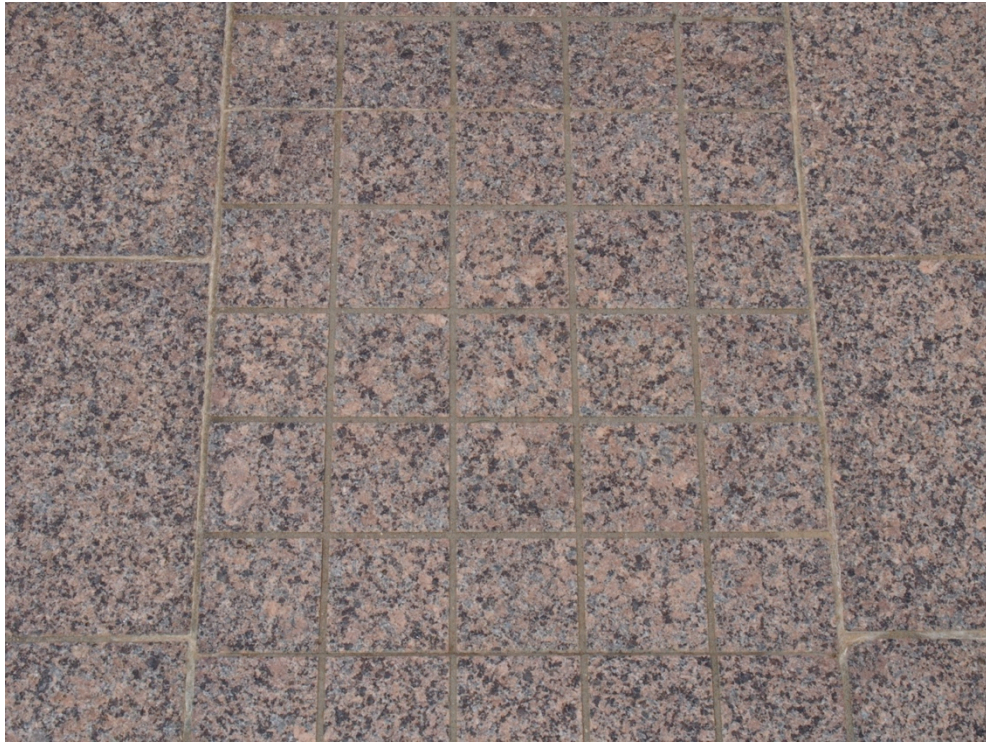
A relatively small number of the pavers are 450mm x 450mm, with a scored grid pattern cut into them, (Fig.3).

Figure 3 450mm x 450mm grid-scored granite paver to forecourt. (Photo: Jasper Swann, 12 February 2020)

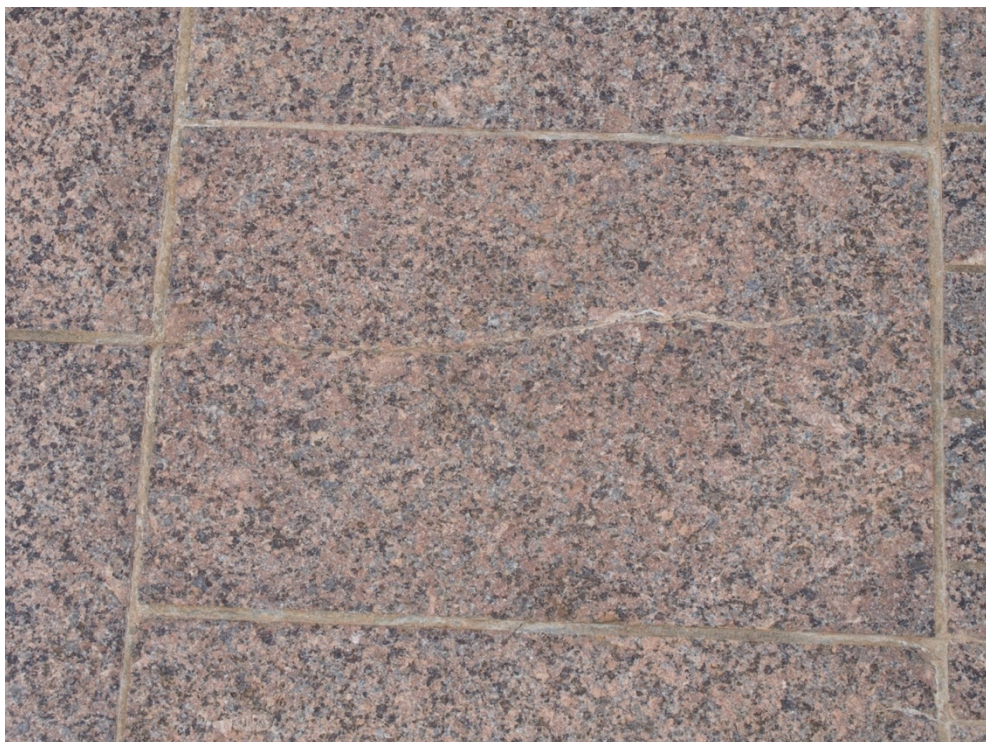
The majority of the pavers are in good condition. A very small number of the pavers exhibit cracking, (Fig.4).

Figure 4 One of several cracked granite pavers to forecourt. (Photo: Jasper Swann, 12 February 2020)

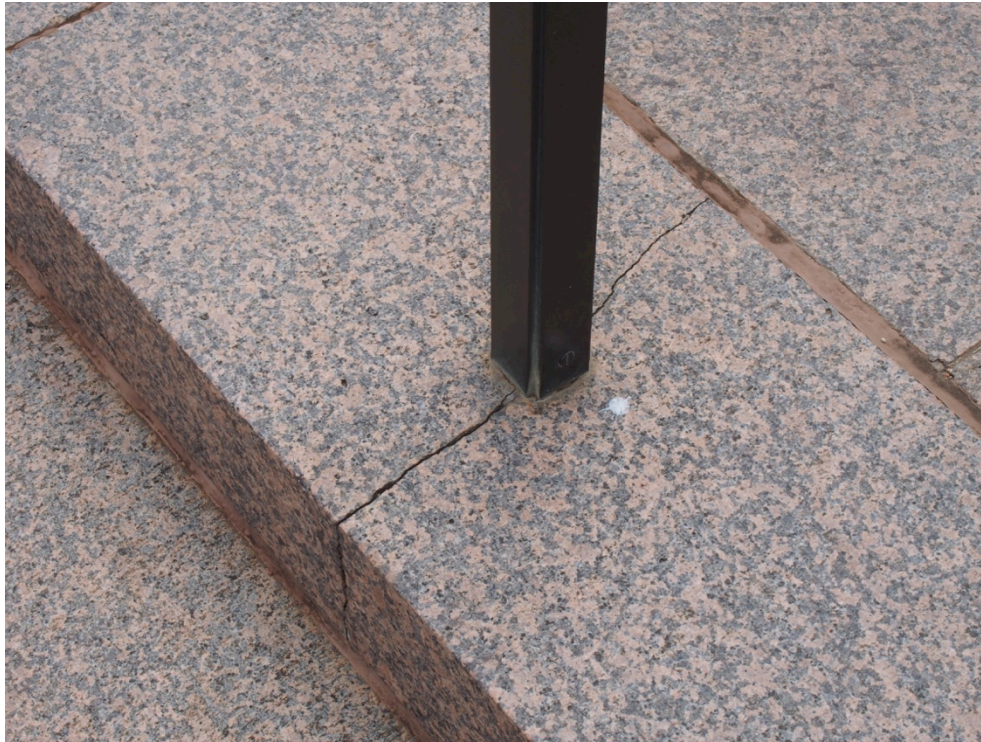
The steps to the Main Entrance are of the same Christmas Bush granite. The treads are solid and range in length from less than a metre to approximately 2.7m. The majority of the treads are in good condition. Two of the treads have cracked across their full tread width, (Figs.5 & 6). A small number of pavers on the landings of the front steps have also cracked.

Figure 5 Cracked granite step tread to forecourt steps. (Photo: Jasper Swann, 12 February 2020)

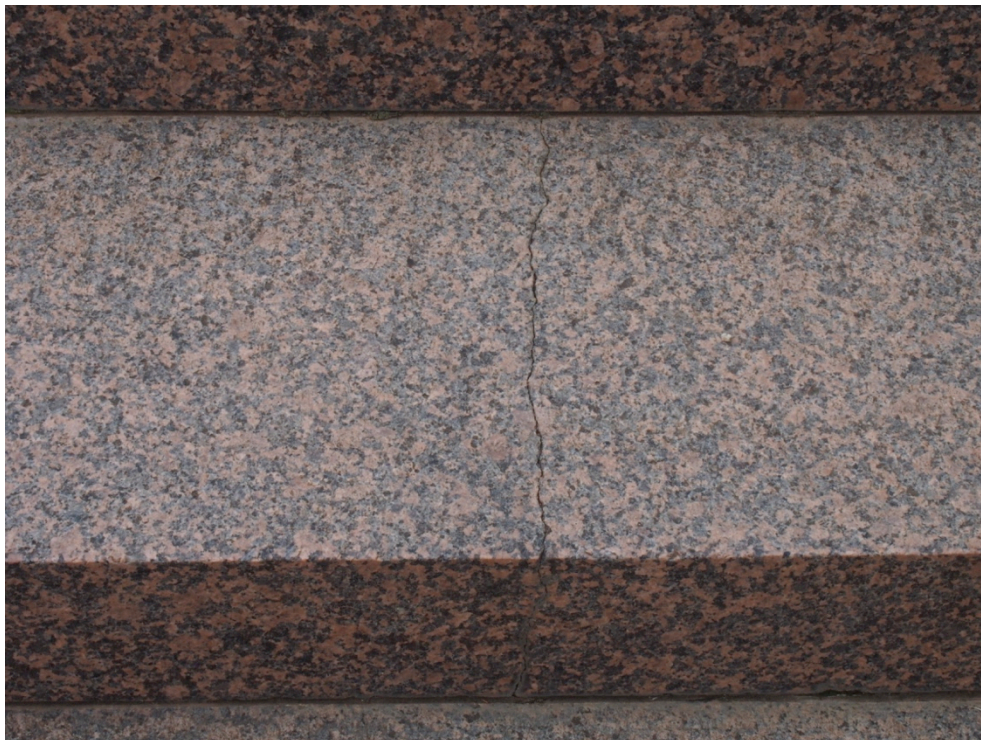
Figure 6 Cracked granite step tread to forecourt steps. (Photo: Jasper Swann, 12 February 2020)

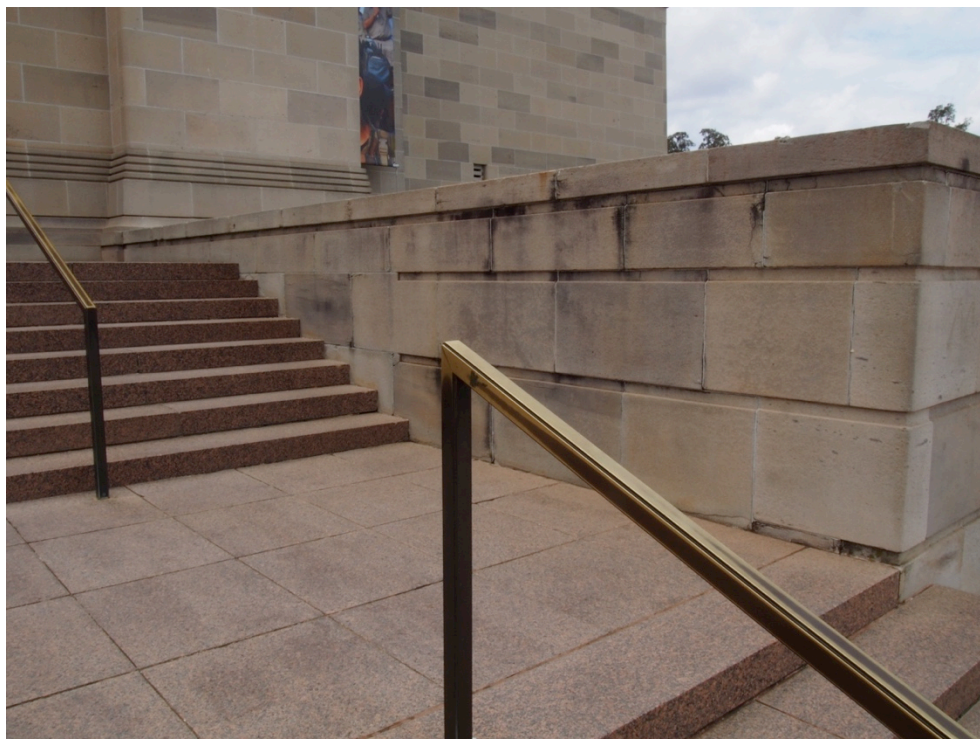
The stonework is generally in fair condition, with the exception of the western elevations of each bastion, where the stone has been deleteriously affected by the western sun. On these elevations, the stonework has suffered extensive cracking and exfoliation. A significant number of stones are beyond repair and would need to be replaced with new in any reconstruction. It is likely that dismantling of the stonework will lead to the loss of corners and arrises where cracking and micro-cracking exists. These instances of damage would best be repaired with reinforced mortar repairs, especially on the very large copings, whose replacement with new would not be considered necessary or good conservation practice. The extent of such mortar repairs could be quite significant. Figures 9-12 show examples of stones that would need to be replaced. Figures 13-19 show examples of existing damage requiring repair.

Figure 7 Eastern bastion wing wall, western elevation. (Photo: Jasper Swann, 12 February 2020)

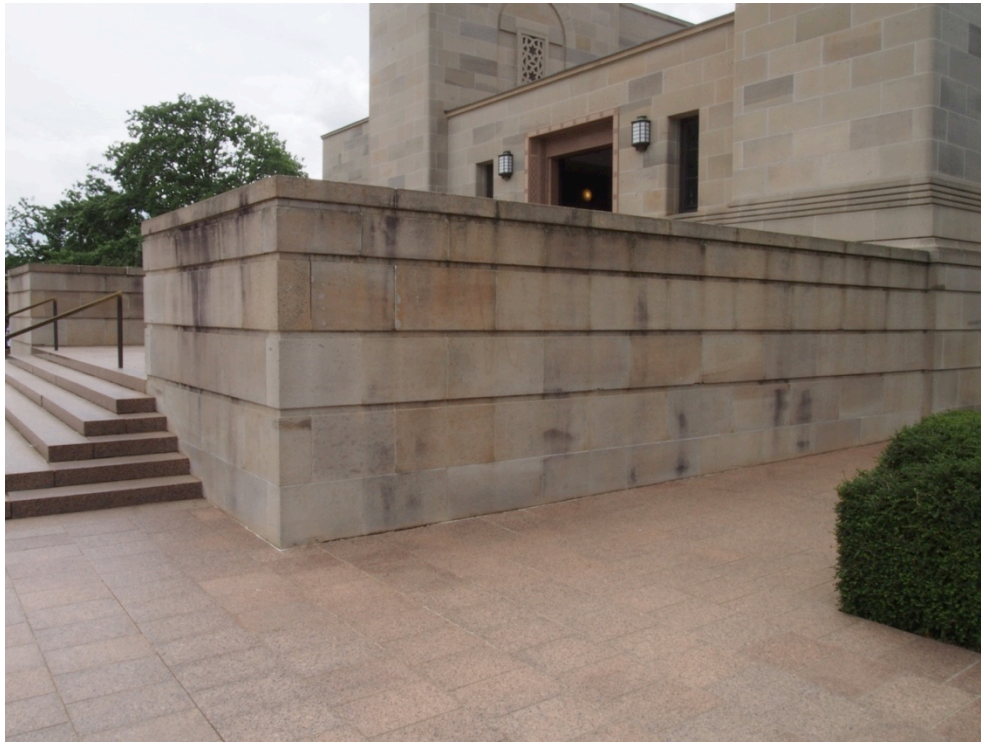
The bastion wing walls consist of what is presumed to be a concrete core, clad in Wondabyne sandstone, (Figs. 7 & 8). Large sandstone copings of approximately 3.5m length span the walls. The face stonework is consistent in detail with the stonework at the same level on the adjoining facades of the main building.

Figure 8 Eastern bastion wing wall, east elevation. (Photo: Jasper Swann, 12 February 2020)

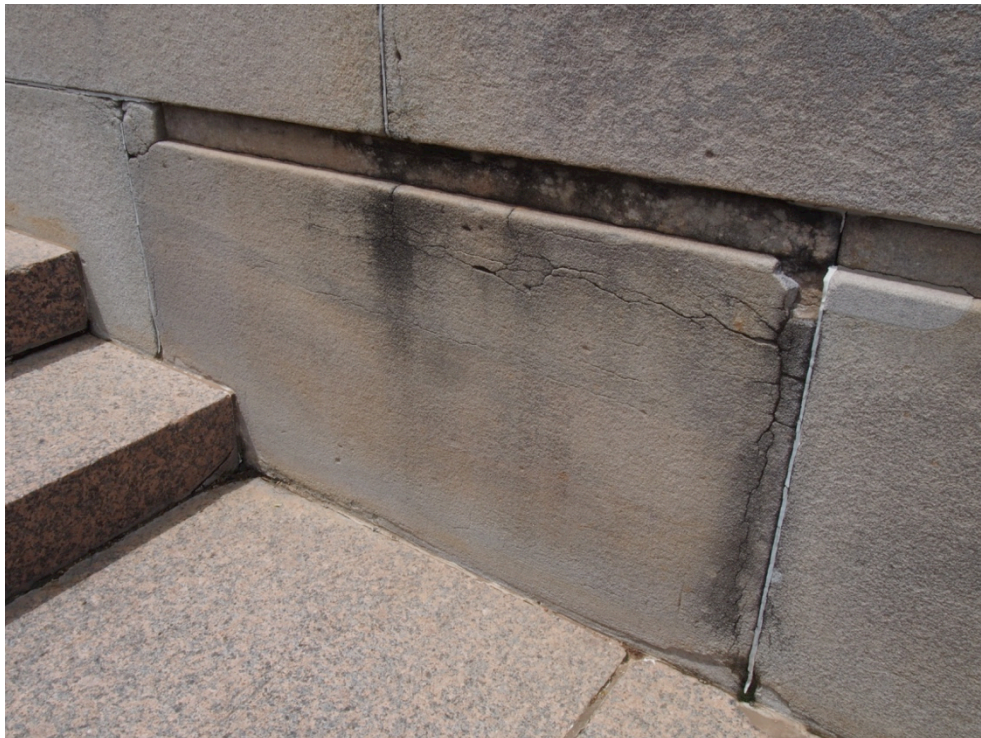
Figure 9 Stone in west elevation of eastern wing wall in poor condition. This stone will require replacement on reconstruction. (Photo: Jasper Swann, 12 February 2020)

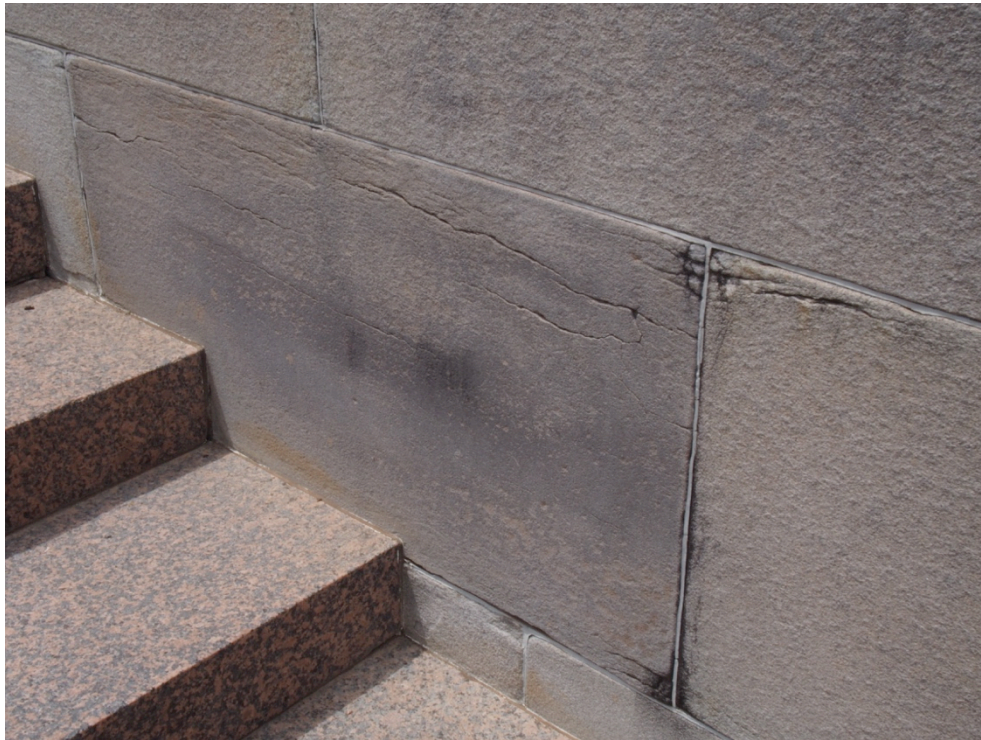
Figure 10 Stone in west elevation of eastern wing wall in poor condition. This stone will require replacement on reconstruction. (Photo: Jasper Swann, 12 February 2020)

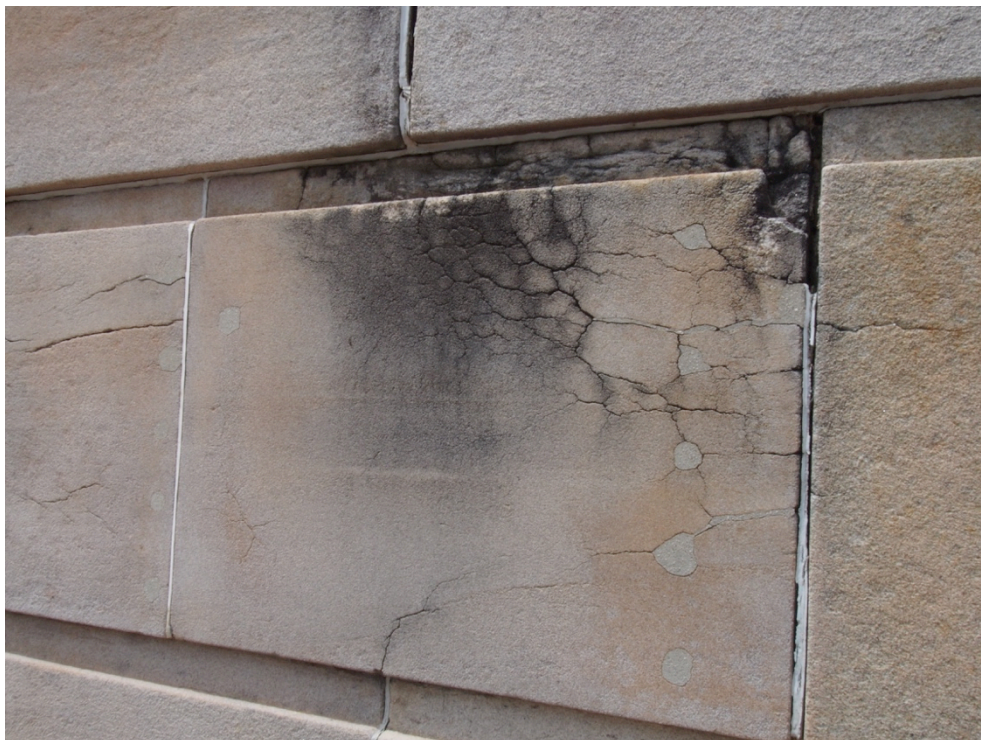
Figure 11 Stone in west elevation of western wing wall in poor condition. This stone will require replacement on reconstruction. (Photo: Jasper Swann, 12 February 2020)

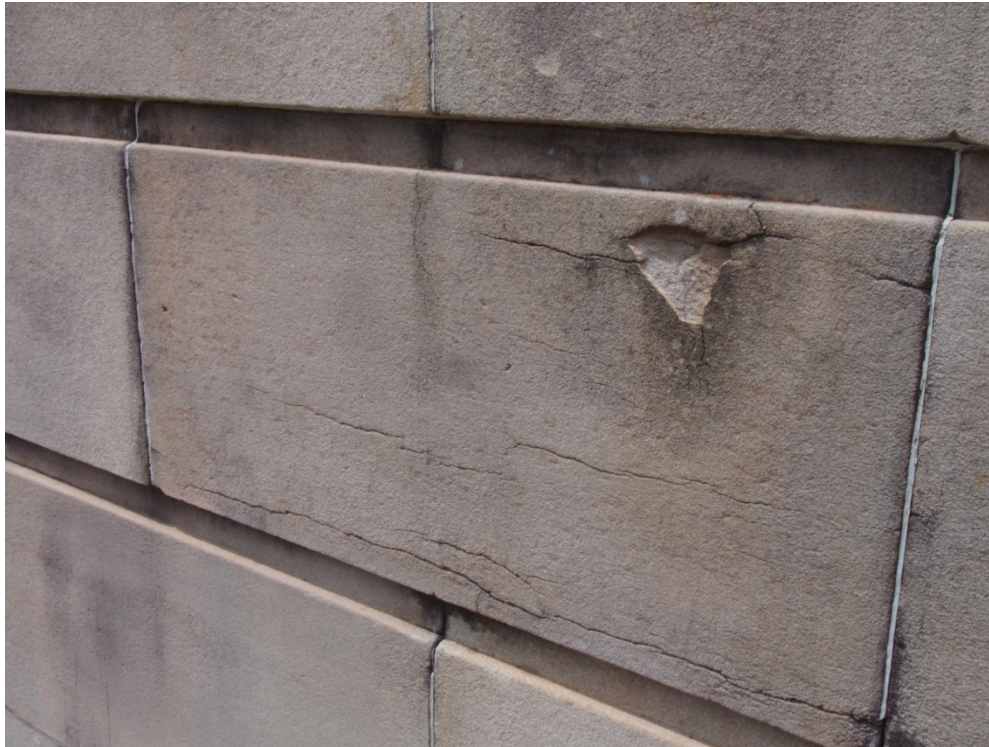
Figure 12 Stone in west elevation of western wing wall in poor condition. This stone will require replacement on reconstruction. (Photo: Jasper Swann, 12 February 2020)

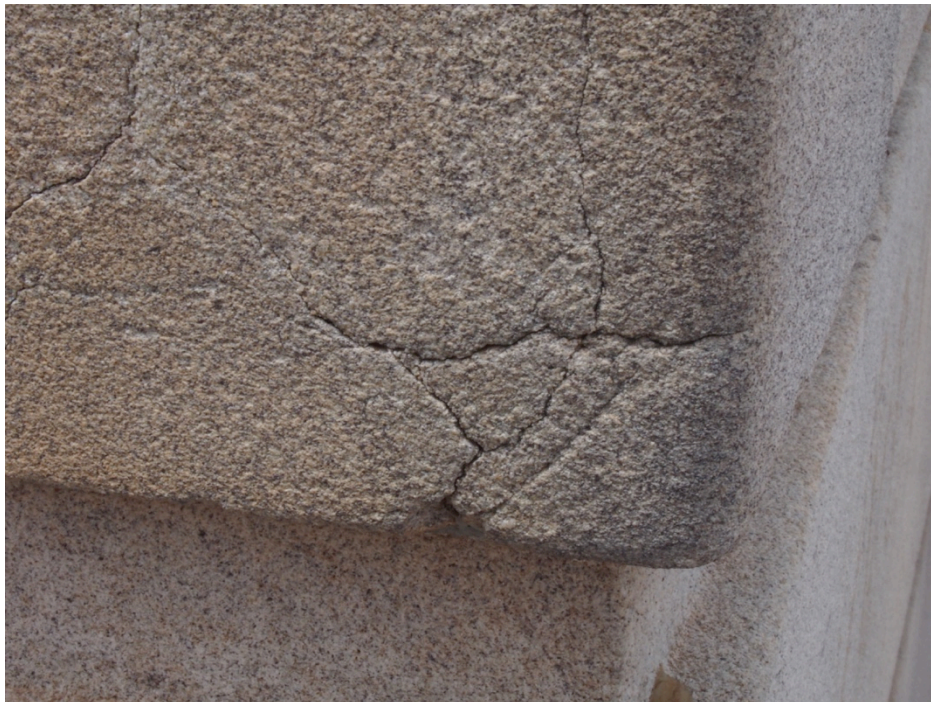
Figure 13 Cracking to external mitre of coping on the eastern bastion wall. This type of deterioration will not withstand dismantling and will require repair, either with mortar repair or hairline indent on reconstruction. (Photo: Jasper Swann, 12 February 2020)

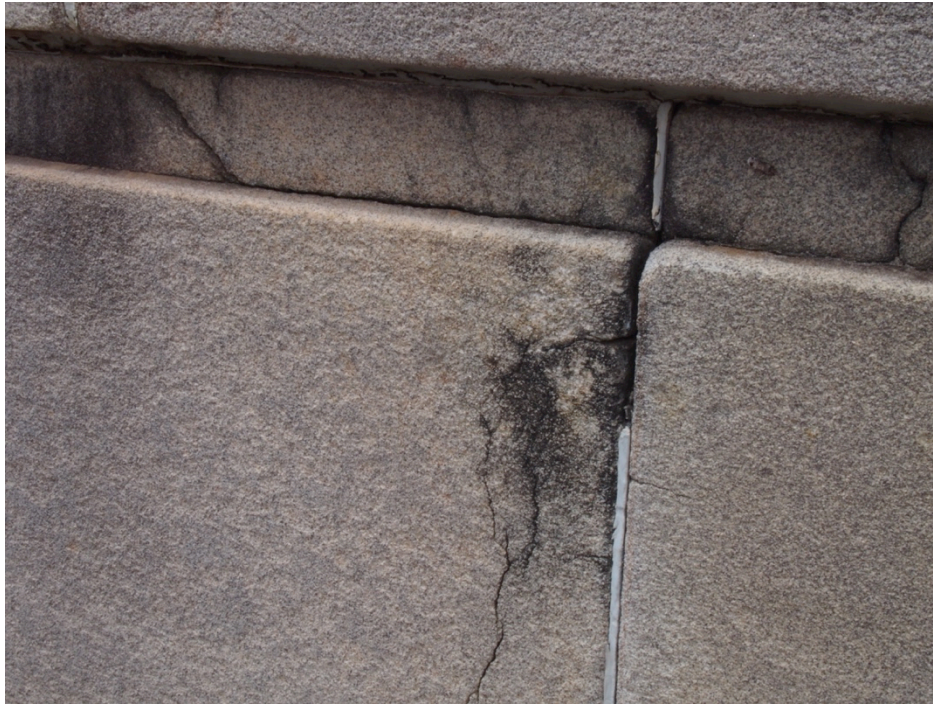
Figure 14 Cracking at edge of ashlar on the eastern bastion wall. This type of deterioration will not withstand dismantling and will require repair, either with mortar repair or hairline indent on reconstruction. (Photo: Jasper Swann, 12 February 2020)

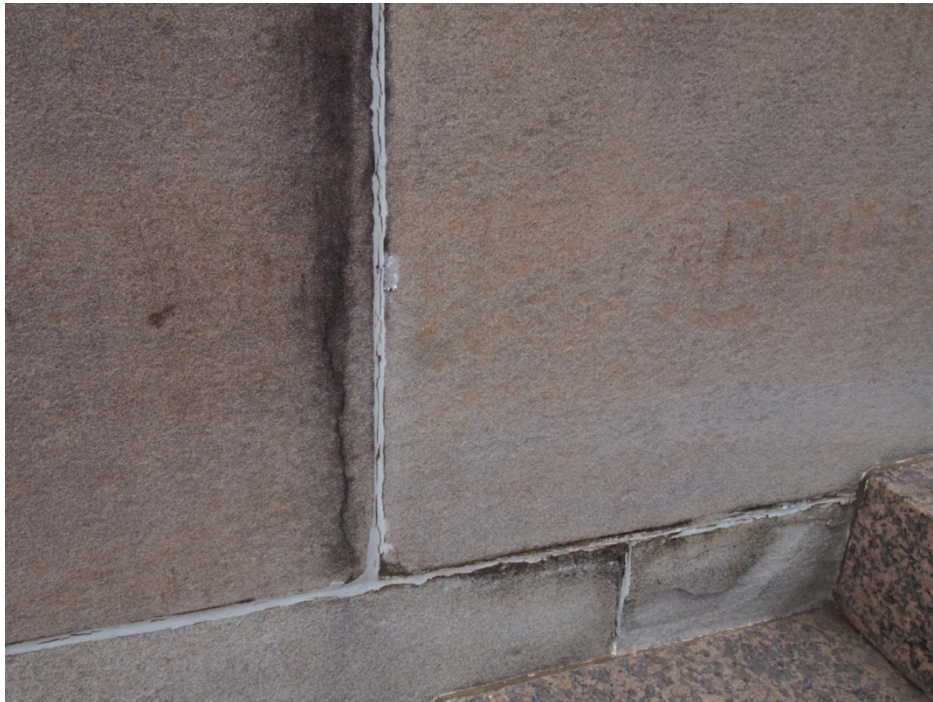
Figure 15 Cracking at edge of ashlar on the western bastion wall. This type of deterioration will not withstand dismantling and will require repair, either with mortar repair or hairline indent on reconstruction. (Photo: Jasper Swann, 12 February 2020)

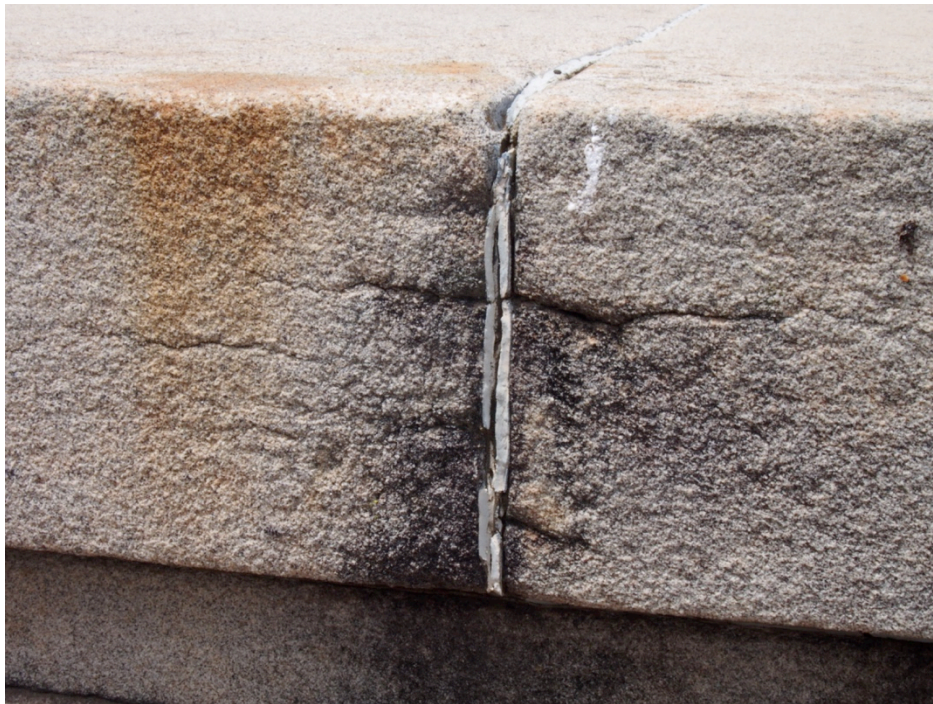
Figure 16 Cracking at edge of copings on the western bastion wall. This type of deterioration will not withstand dismantling and will require repair, either with mortar repair or hairline indent on reconstruction. (Photo: Jasper Swann, 12 February 2020)

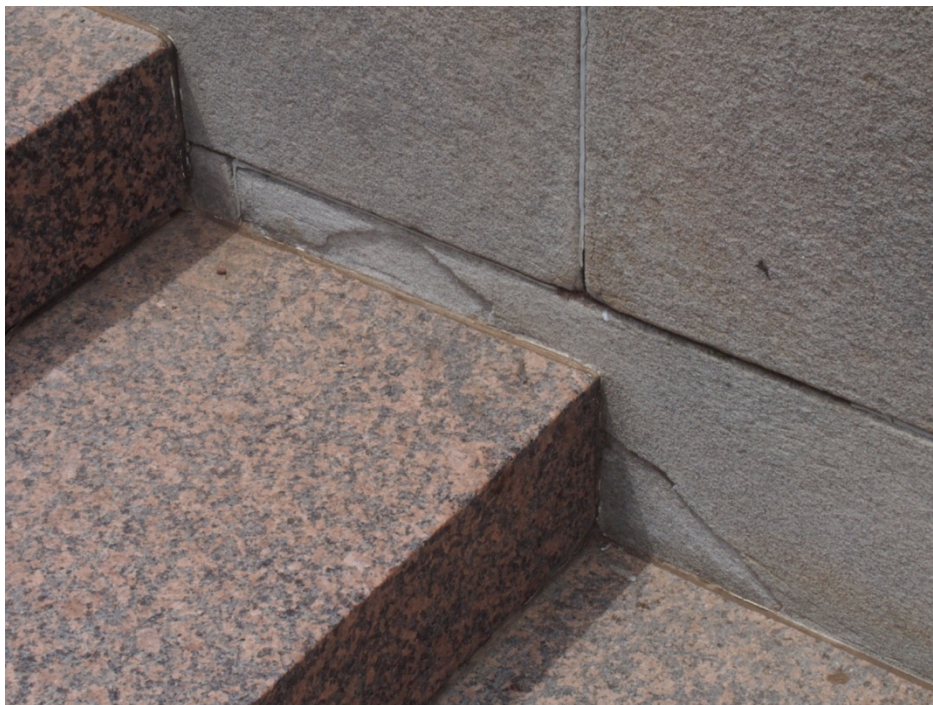
Figure 17 Localised exfoliation to ashlar at the abutment of the granite steps.
Replacement or repair of the sandstone will be required on reconstruction of the bastion wing walls. (Photo: Jasper Swann, 12 February 2020)

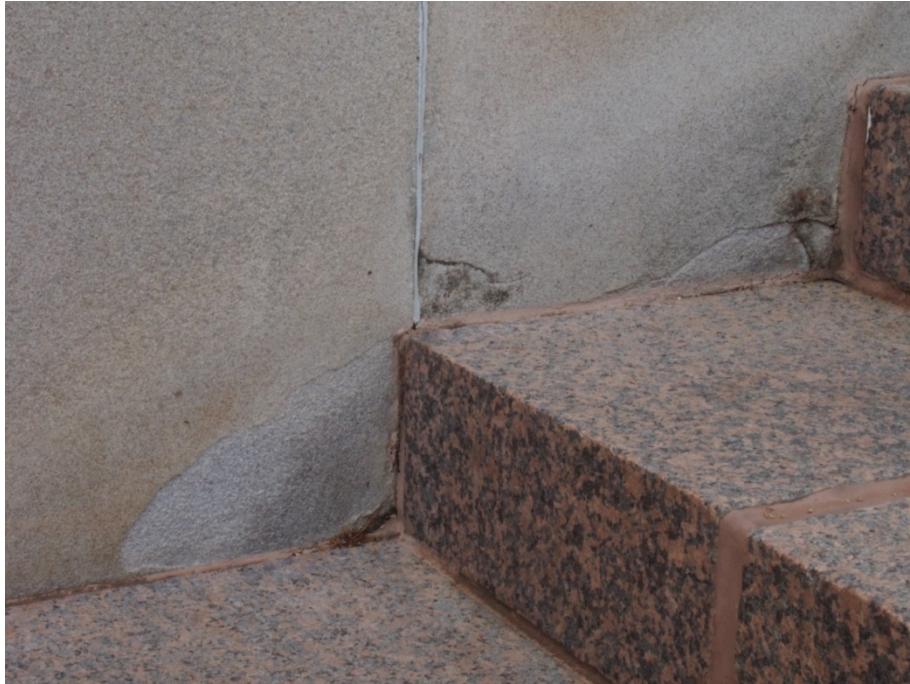
Figure 18 Localised exfoliation to ashlar at the abutment of the granite steps.
Replacement or repair of the sandstone will be required on reconstruction of the bastion wing walls. (Photo: Jasper Swann, 12 February 2020)

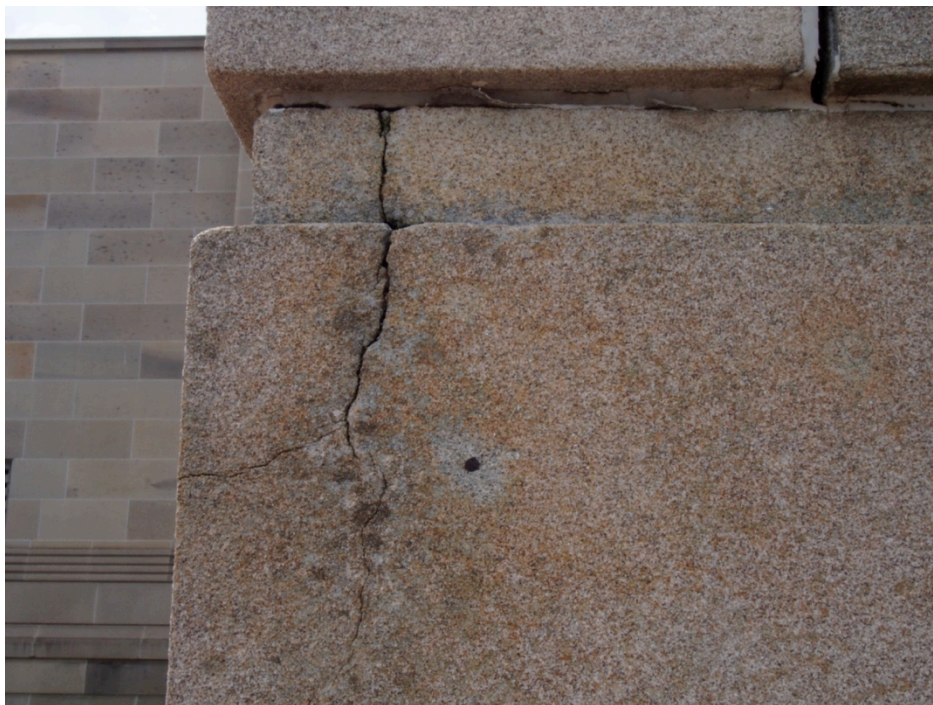
Figure 19 Significant cracking in upper course to western bastion wing wall. This type of cracking will not withstand dismantling and will require repair using mortar repair or hairline indent on reconstruction. (Photo: Jasper Swann, 12 February 2020)

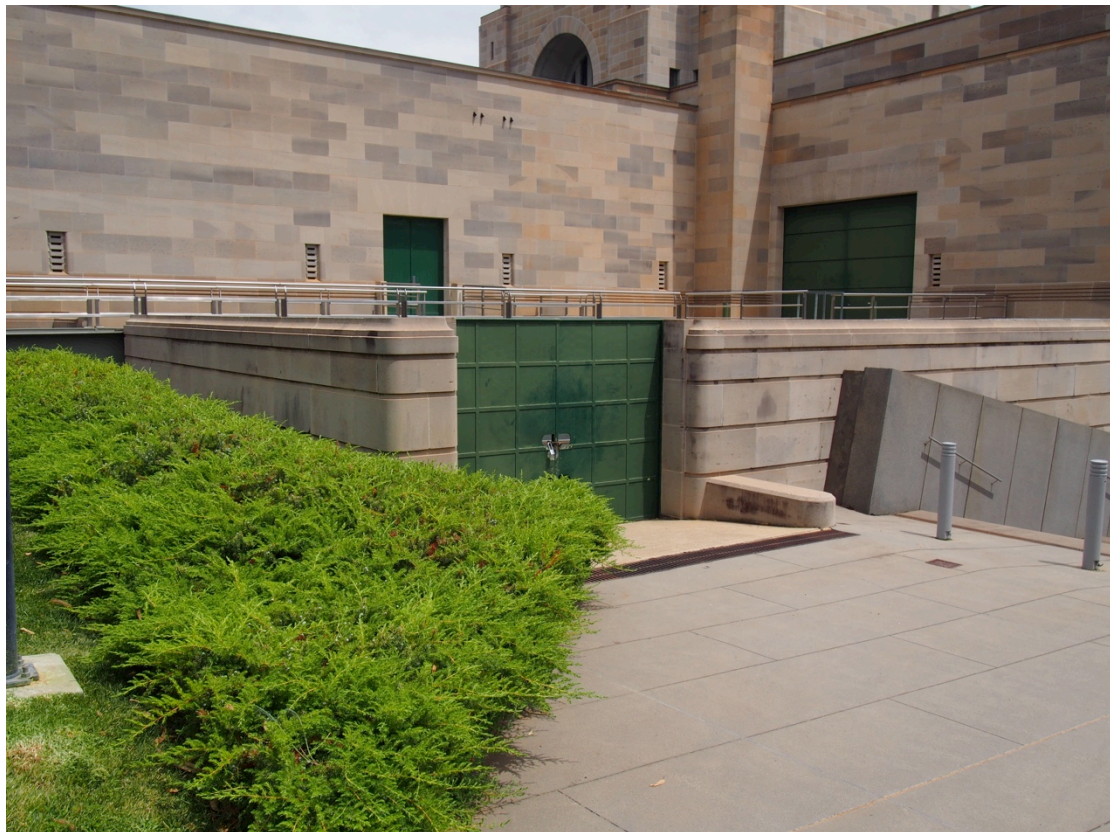
Figure 20 The lower walls around the plant room are to be partially demolished. Careful dismantling and salvage of the sandstone in these walls is recommended, as there is potential for reuse in the reconstruction of the bastion wing walls at the front entrance. (Photo: Jasper Swann, 12 February 2020)

I understand that the stonework surrounding the existing plant room at the northeast corner of the building is to be demolished as part of forthcoming works, (Fig.20). An option for replacing the worst stones in the bastion walls at the front (southern) entrance would be to salvage the stonework from the plant room walls and reuse it where possible in the reconstructed bastion walls. Dismantling of the plant room walls, setting aside for reuse, and protection of the stonework would need to be undertaken by skilled masons. It is likely that there would be sufficient quantity to undertake the necessary replacement using this approach. Mortar repairs to smaller areas of damage would still be required.

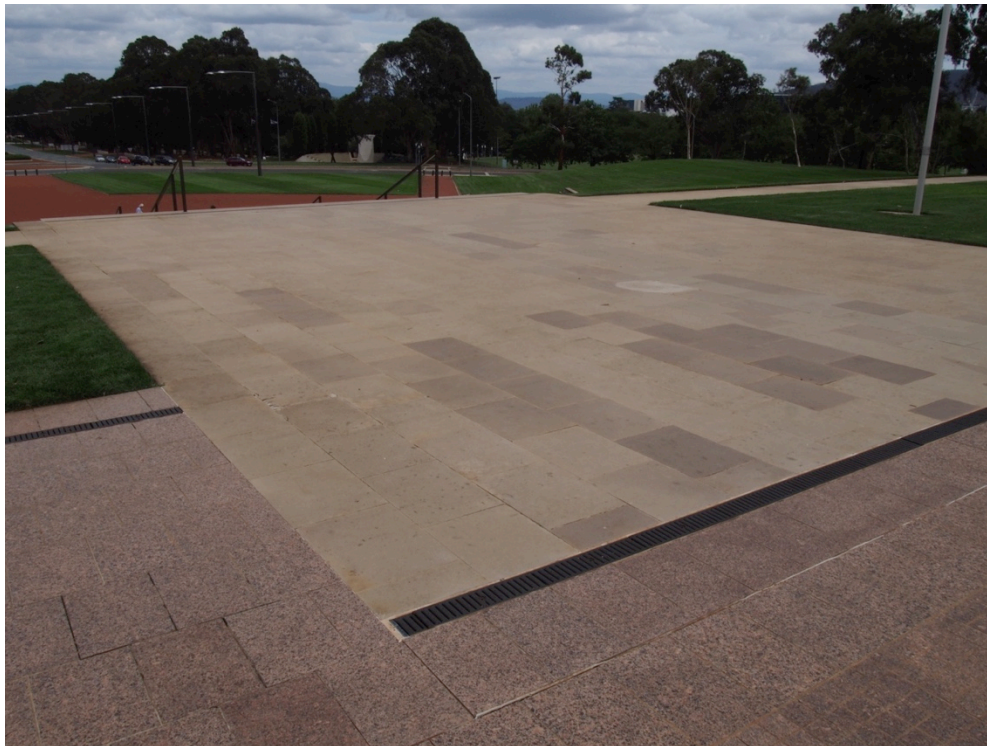
Figure 21 Sandstone paving to forecourt. (Photo: Jasper Swann, 12 February 2020)

There are several areas of sandstone paving located across the parade ground and forecourt. The paving is in generally good condition, with localised exceptions, (see Figs. 21 -24). The stone is Wondabyne sandstone.

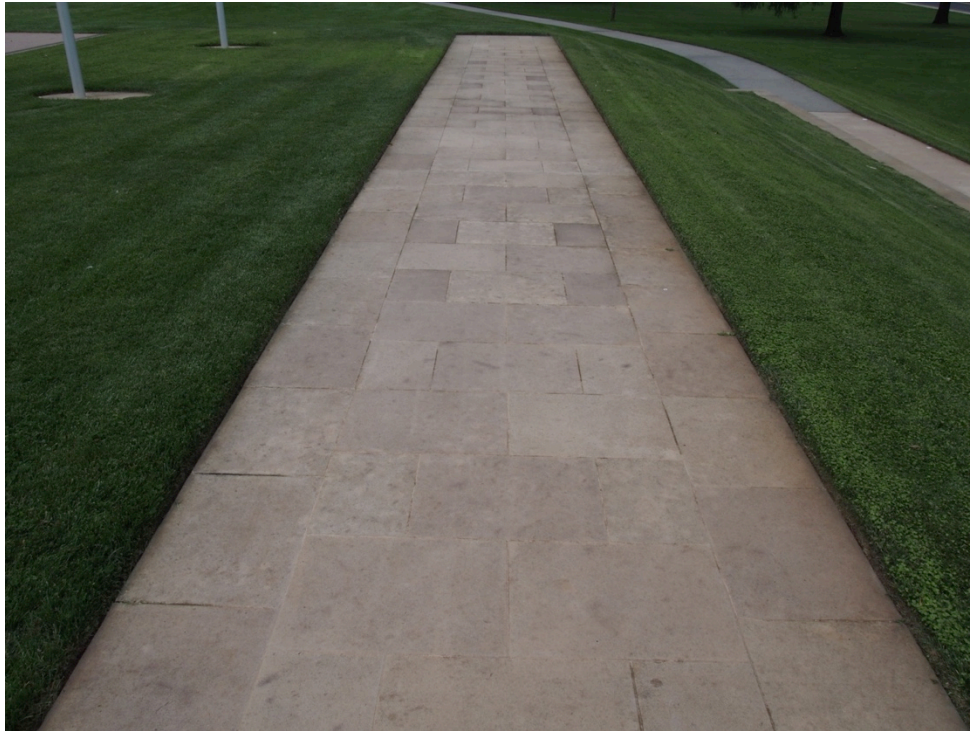
Figure 22 Sandstone paving extending to the east, mirrored by the same paving extending to the west (not shown). (Photo: Jasper Swann, 12 February 2020)

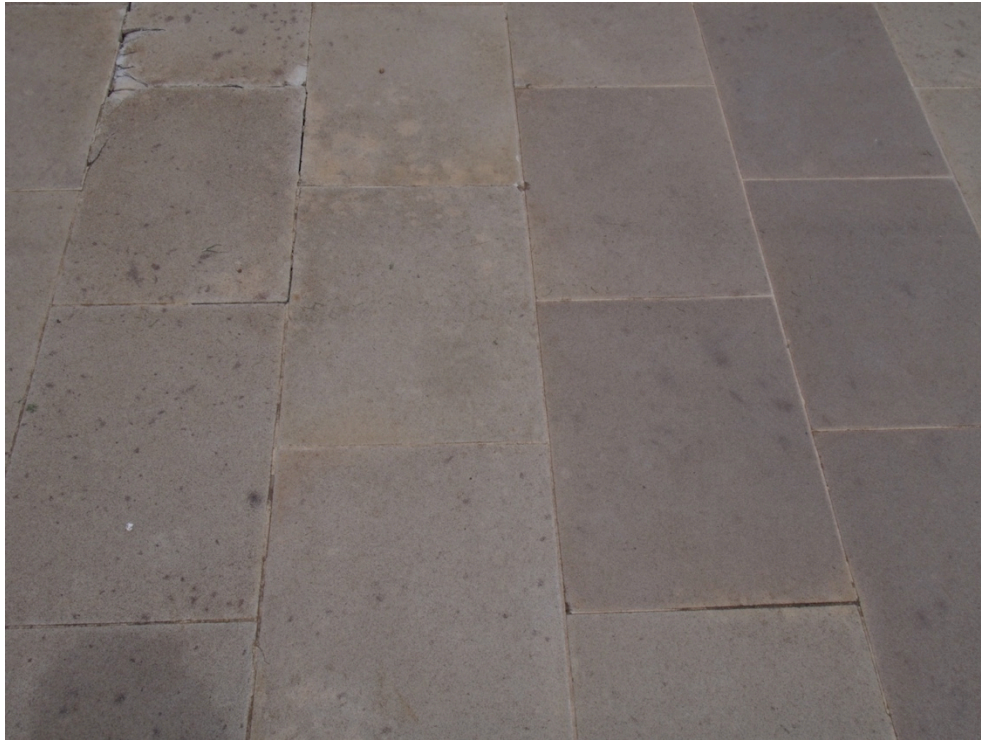
Figure 23 600mm x 420mm Wondabyne sandstone paving to the forecourt. (Photo: Jasper Swann, 12 February 2020)

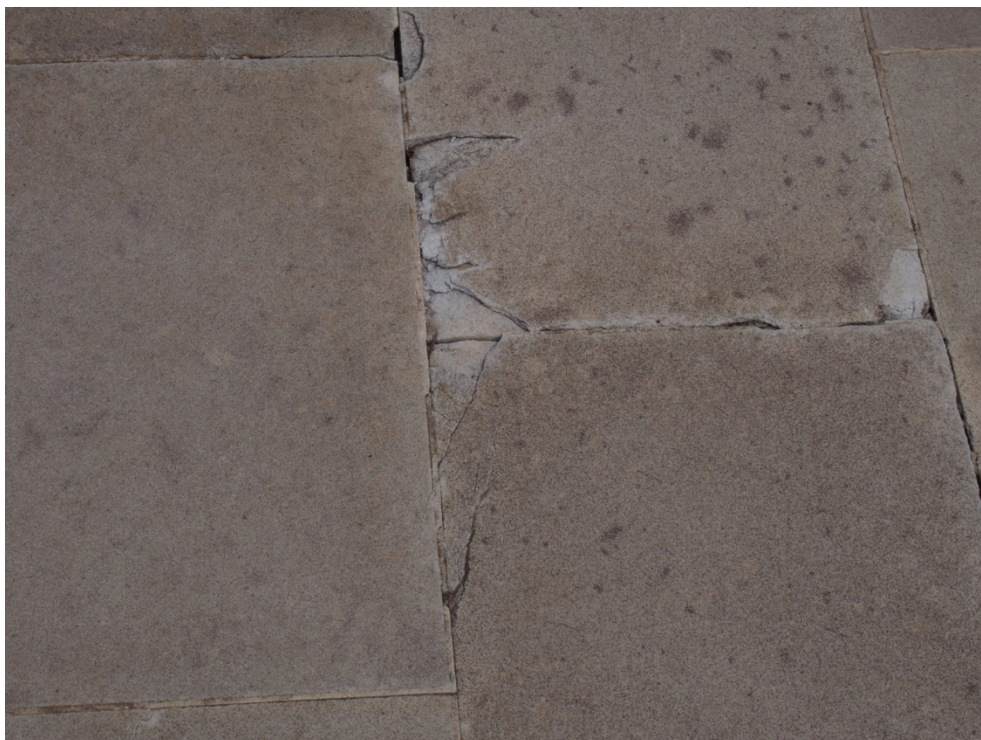
Figure 24 Localised damage to sandstone paving. The majority, however, is in good condition. (Photo: Jasper Swann, 12 February 2020)

It is likely that the sandstone pavers were laid on a wet cement bed, as per the adjacent granite paving. This being the case, it is also likely that an attempt to raise and salvage the paving may prove to be an exercise that yields a low return of reusable paving. It is recommended that a trial be conducted to attempt careful removal of the sandstone pavers over an area of, say, 2 sq m, to assist in evaluation as to whether the material can be successfully reused in the redevelopment. These works should be undertaken by skilled masons.

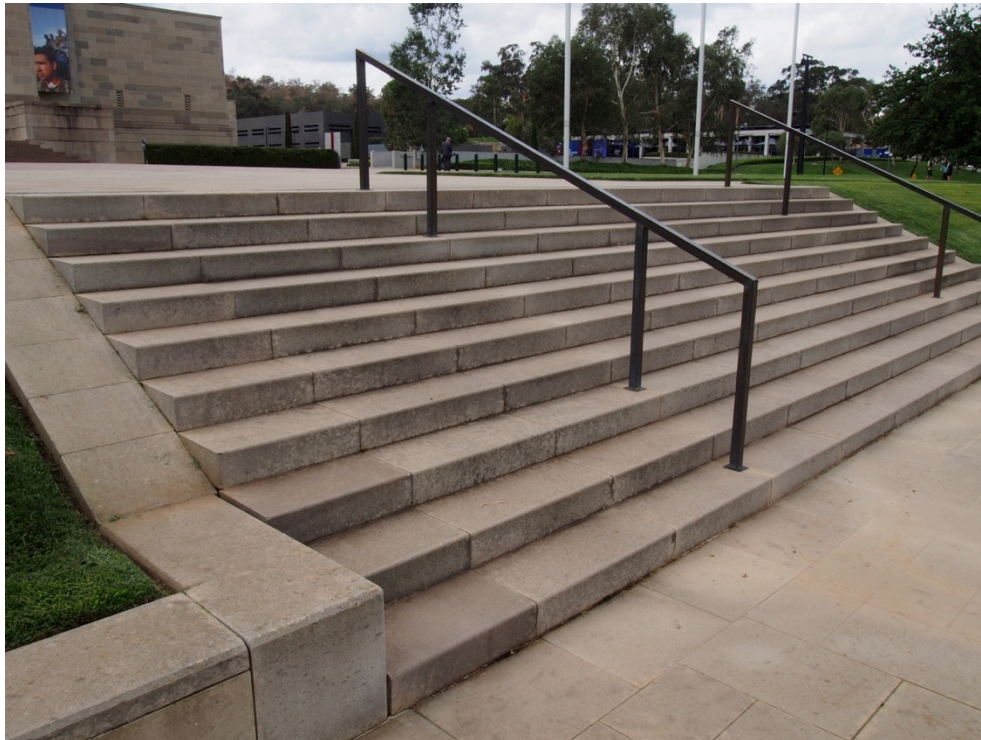
The steps are of Wondabyne sandstone and comprise solid treads. There are three flights of sandstone steps leading to the lower tiers of the parade ground: One straight flight, (Fig.25), and two curved-on-plan, (Fig.26). The sandstone treads in the curved-on-plan steps are not worked to a curvature but are in fact straight units.

Figure 25 Wondabyne sandstone step treads to lower forecourt. Steps are in good condition. (Photo: Jasper Swann, 12 February 2020)

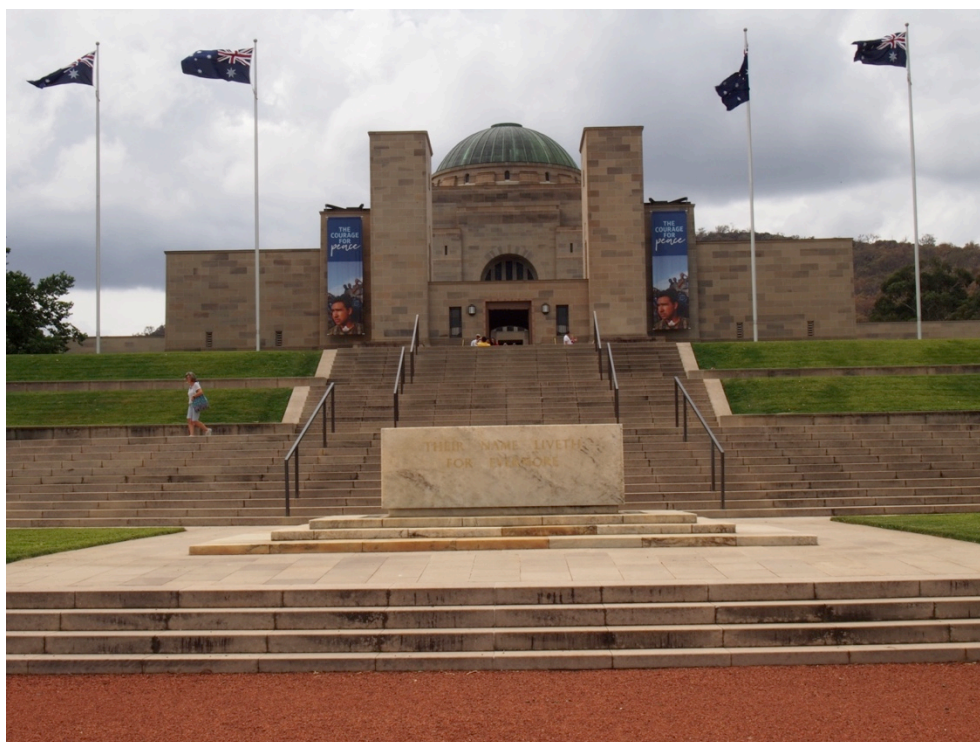
Figure 26 Three tiers of Wondabyne sandstone steps (seen behind the Stone of Remembrance), all in good condition. (Photo: Jasper Swann, 12 February 2020)

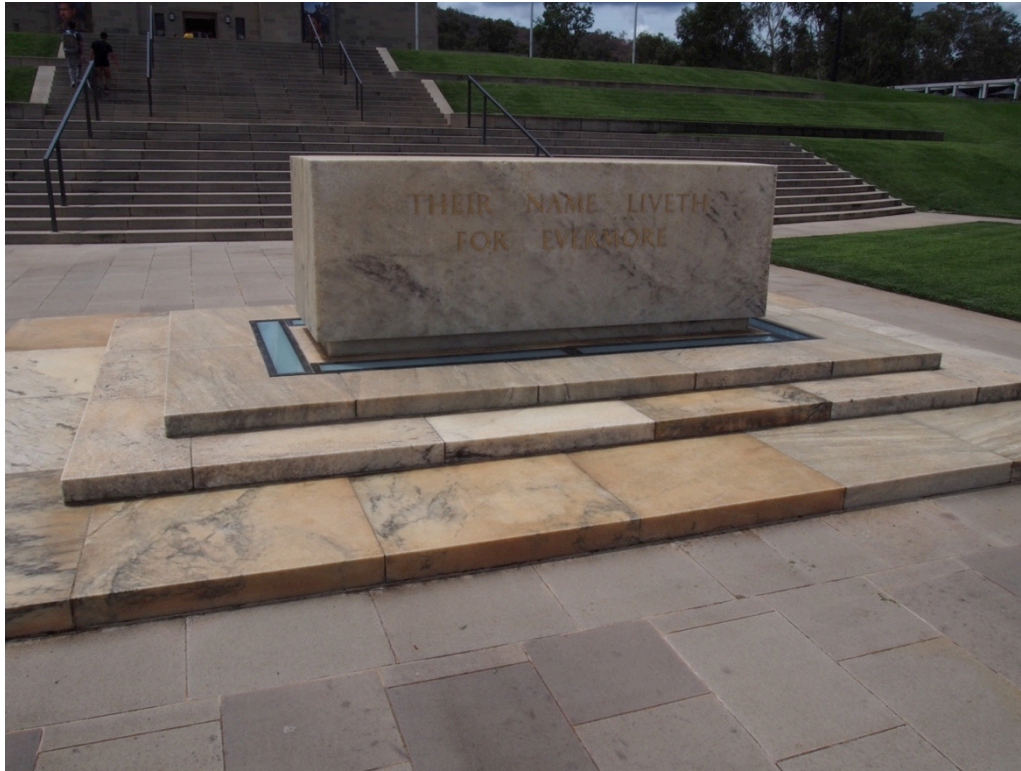
The Stone of Remembrance consists of three broad tiers of marble steps and a central monolithic stone of the same marble, (Fig.27). The marble is generally in good condition. There are several cracks in the steps that would be likely to open up during dismantling, (Figs 28-31). Great care would be required to successfully dismantle the structure to minimise damage. Repair works to broken step treads would need to be undertaken in a workshop environment. The dismantling and repair works would need to be undertaken by skilled masons.

Figure 27 The Stone of Remembrance. (Photo: Jasper Swann, 12 February 2020)

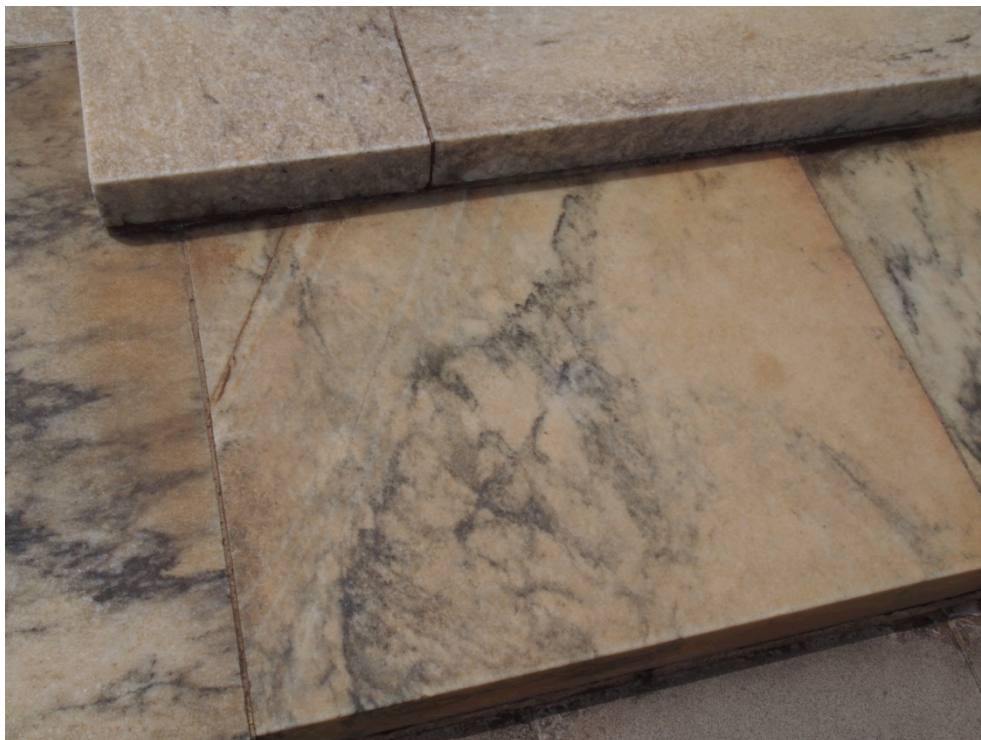
Figure 28 Cracking in marble step (top left corner), likely to break when dismantling. (Photo: Jasper Swann, 12 February 2020)

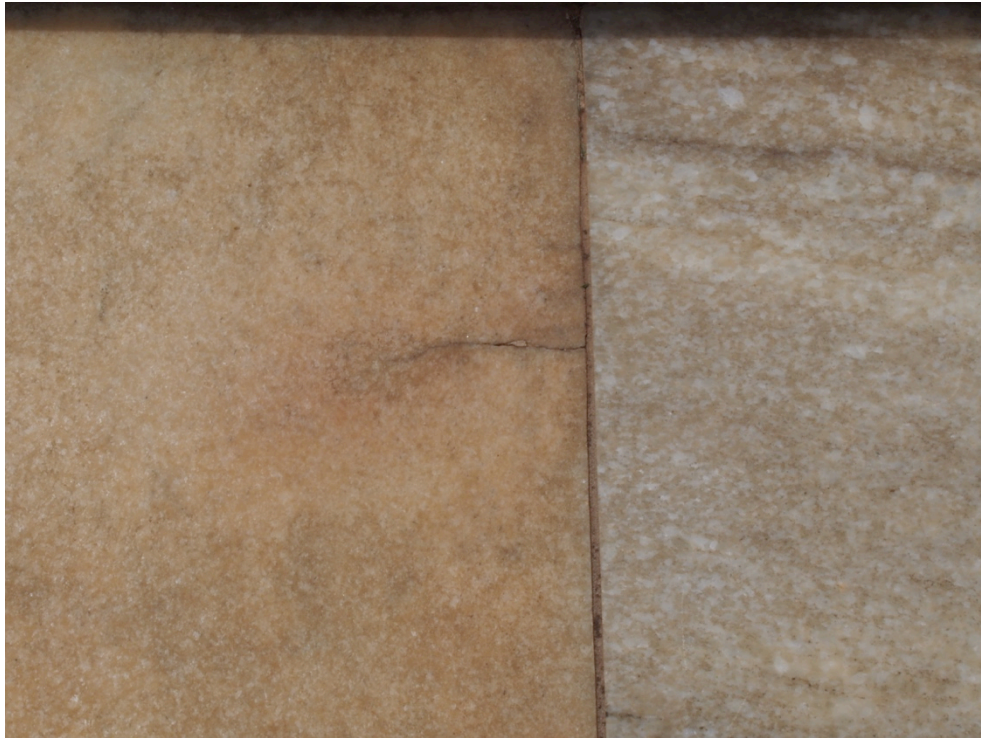
Figure 29 Cracking either side of joint in marble step course. (Photo: Jasper Swann, 12 February 2020)
