AUSTRALIAN WAR MEMORIAL

NEW SOUTHERN ENTRANCE REDEVELOPMENT PROJECT

FEASIBILITY REPORT ON DISMANTLING AND REUSE OF EXISTING STONE ELEMENTS

20 February 2020

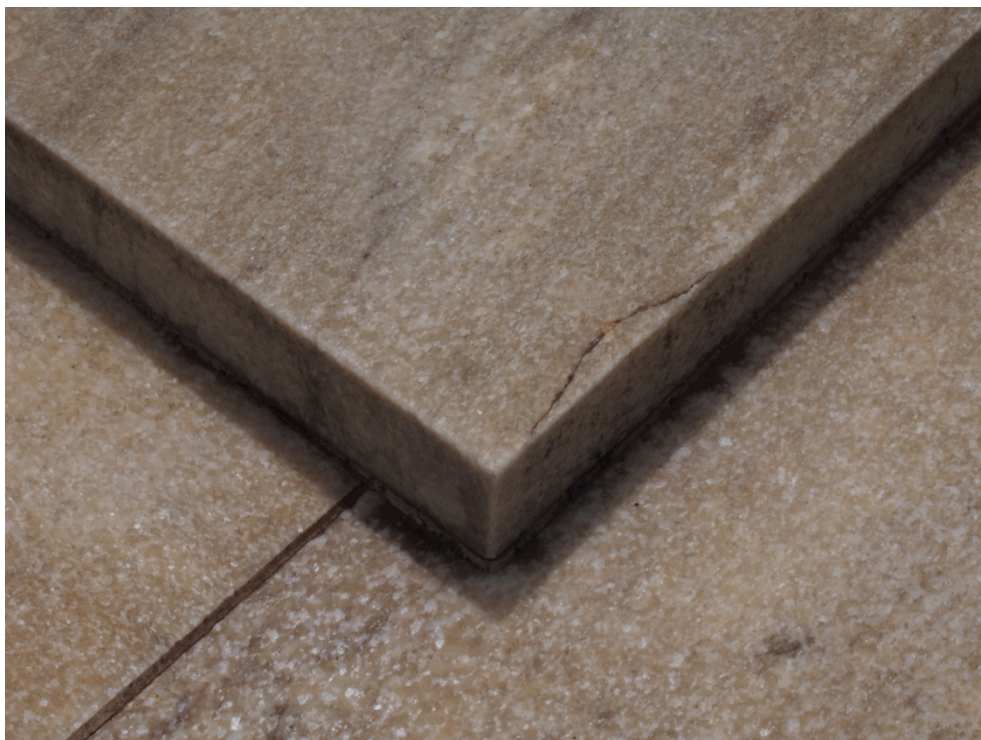
Figure 30 Cracking to leading edge of marble step requiring glue repair prior to dismantling. (Photo: Jasper Swann, 12 February 2020)

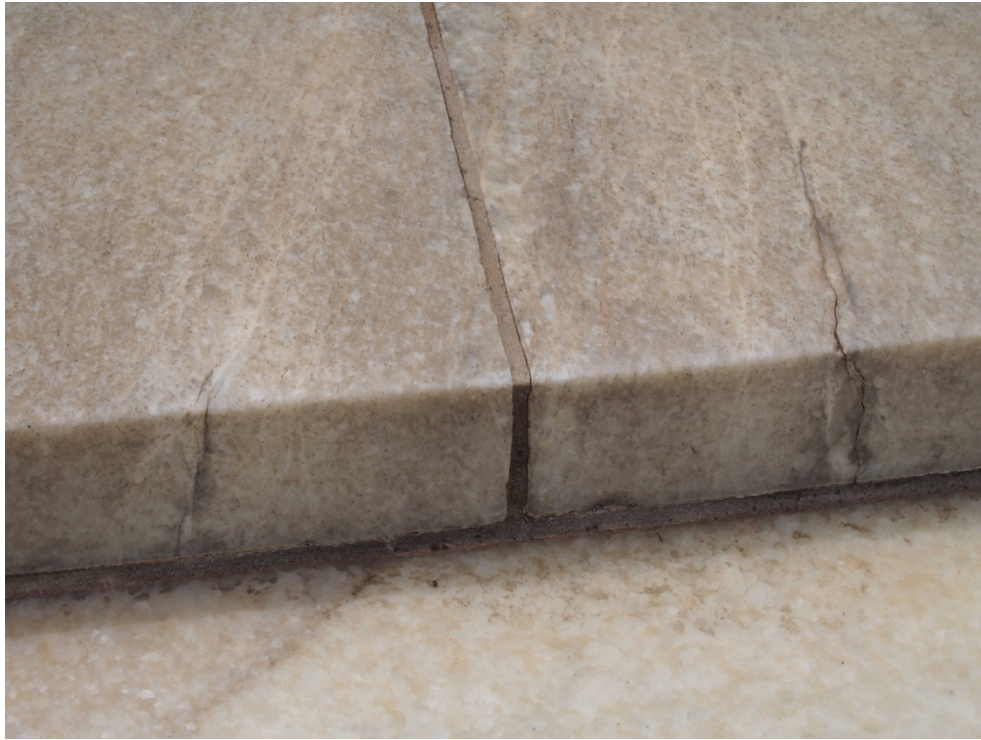
Figure 31 Cracking in marble step likely to break during dismantling. (Photo: Jasper Swann, 12 February 2020)
