# ASBESTOS MANAGEMENT PLAN (AMP)

REPORT NO: KE1012 AMP

Australian War Memorial (AWM)

Treloar Crescent, Campbell ACT 2612

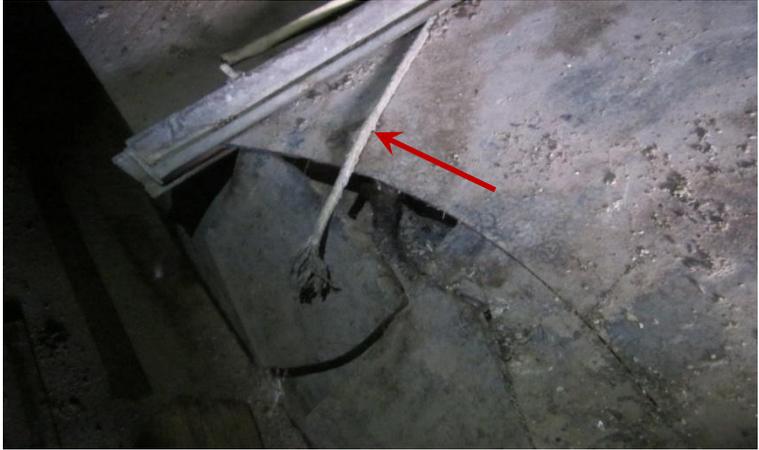
Main Building			
ITEM NO	ACM TYPE	LOCATIONS	PHOTOGRAPH
1	Rope	AWM – to windows through access hatch adjacent to tower roof access

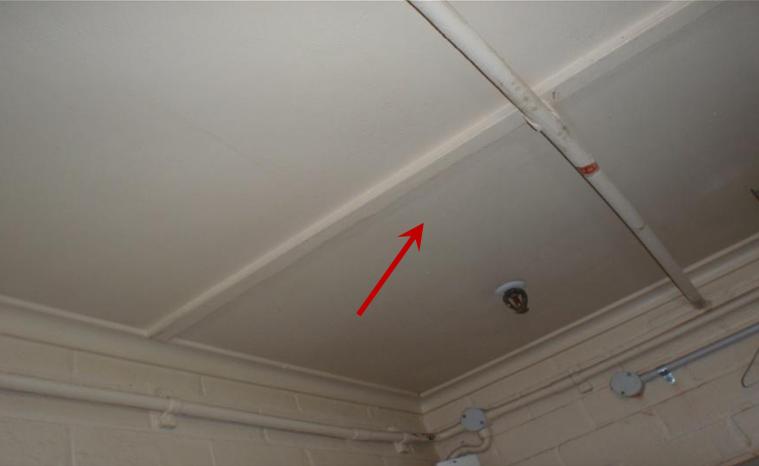
2	Sheet	Cleaners' rooms ceiling sheet (Main building)

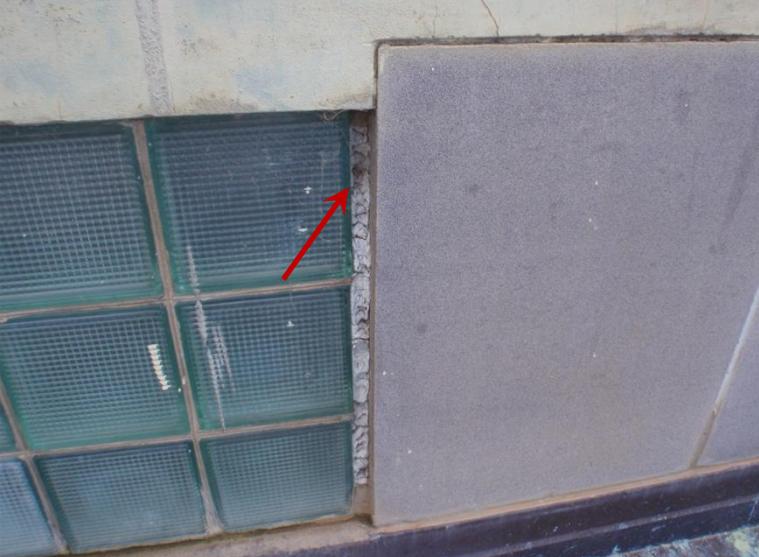
3	Mastic	AWM – Glass cubes on roof by tower at sides

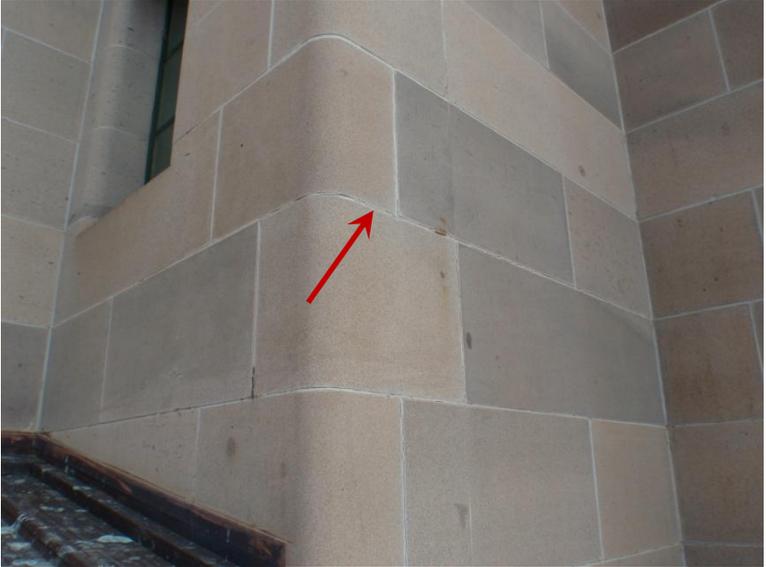
Main Building			
ITEM NO	ACM TYPE	LOCATIONS	PHOTOGRAPH
4	Mastic	AWM – To external sandstone block

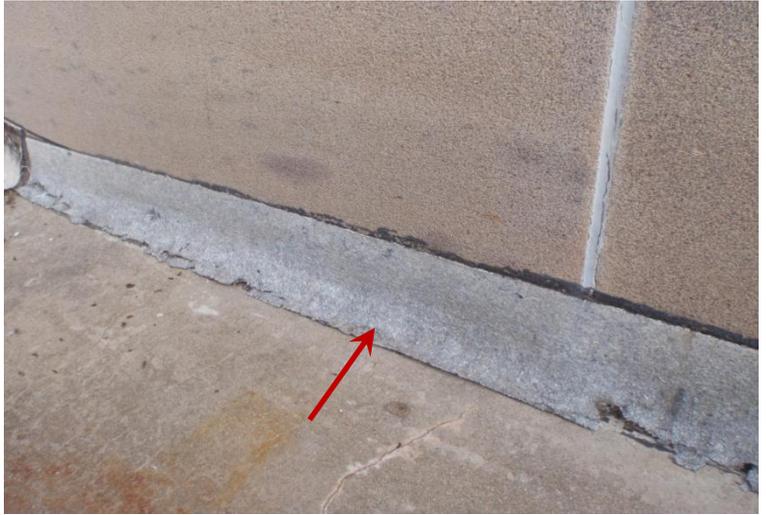
5	Bitumen Membrane	Adjacent to external cooling tower plant area

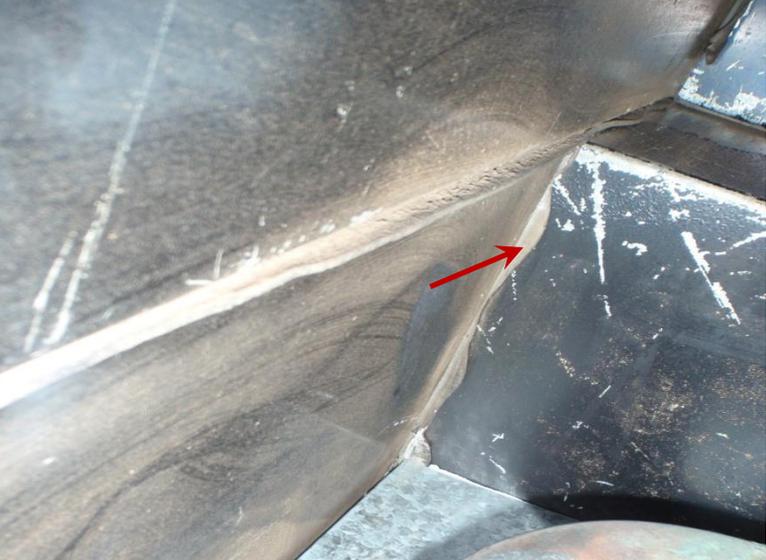
6	Mastic	AHU 3.1 Plant room 3 internal joints

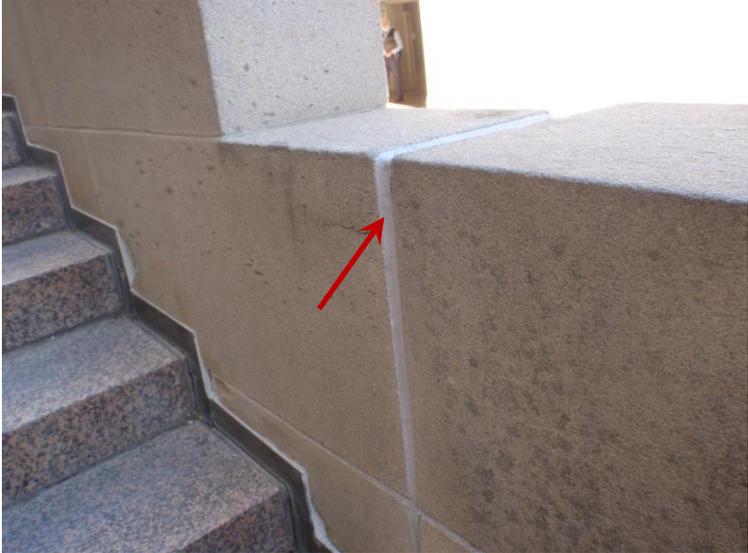
Main Building			
ITEM NO	ACM TYPE	LOCATIONS	PHOTOGRAPH
7	Mastic	AWM – Commemorative area steps adjacent main entrance to sandstone

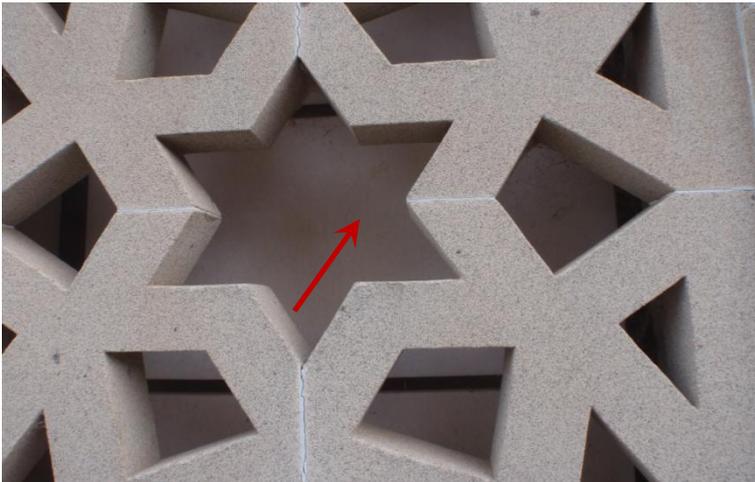
8	Sheet	To window panels on lift shaft level 3 commemorative area

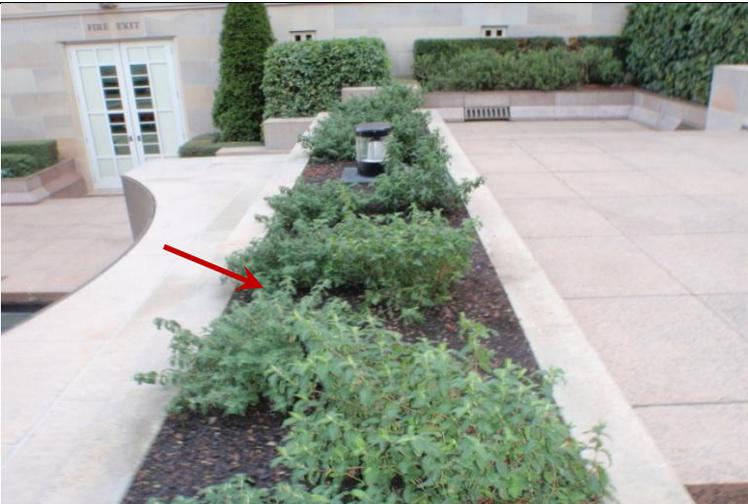
9	Sheet	Garden bed in commemorative area – Main AWM building

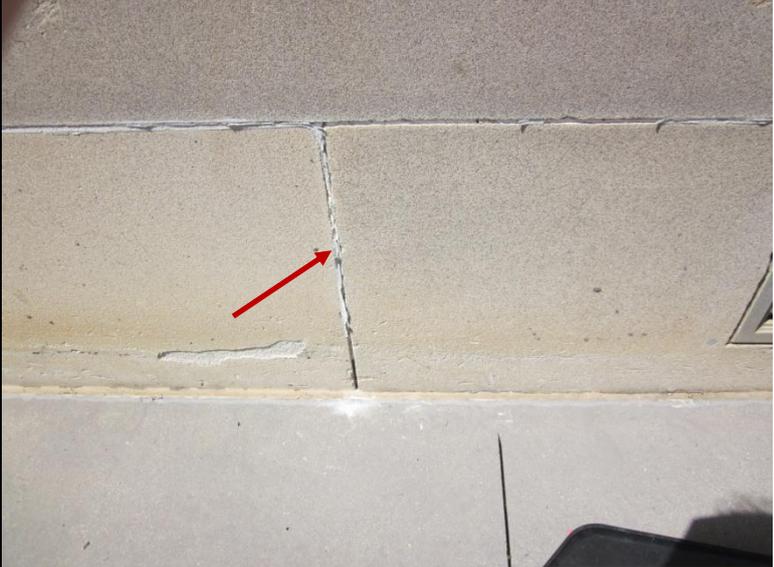
Main Building			
ITEM NO	ACM TYPE	LOCATIONS	PHOTOGRAPH
10	Caulking	West wall near security entrance – vertical white caulking

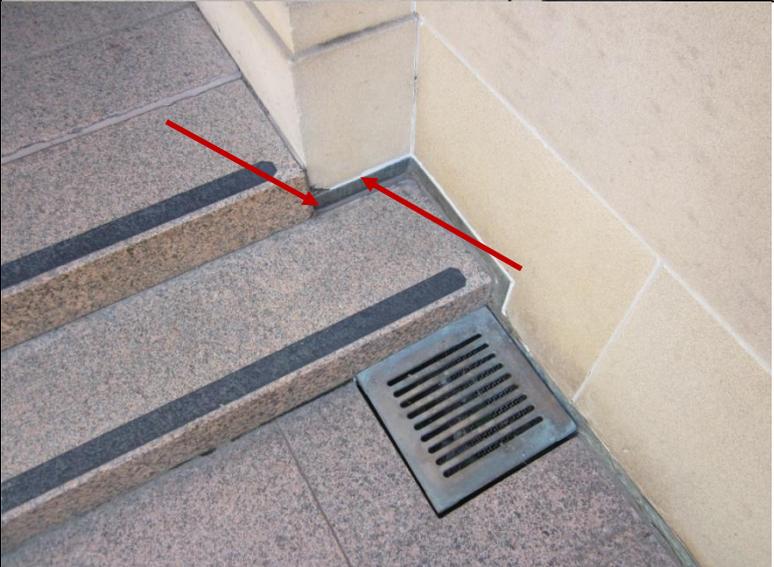
11	Caulking	Commemorative courtyard south west near drain – white and grey caulking

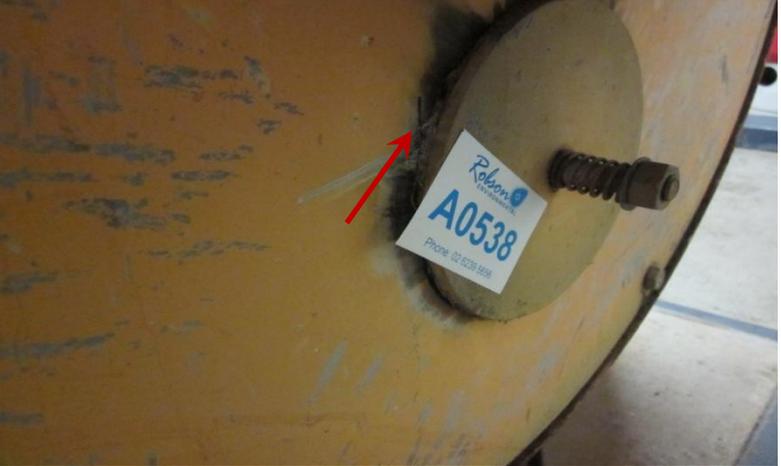
Admin Building			
ITEM NO	ACM TYPE	LOCATIONS	PHOTOGRAPH
12	Rope	To rear of boilers around small plate in plant room

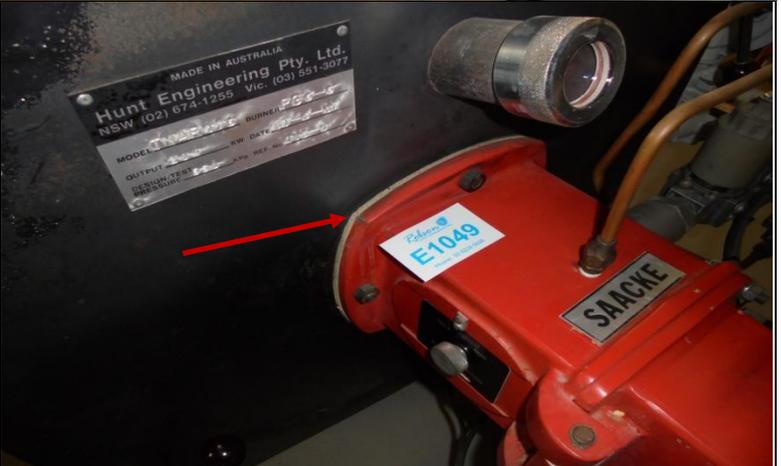
Administration building	12/10/2020	Keane Environmental	NA	AD3	At front of red burner units attached to the boilers x2 in main plant room	Gasket	Friable & good	Chrysotile asbestos detected	Very Low	Removed during plant room refurbishment

13	Gasket	To front of boilers x 2 in plant room

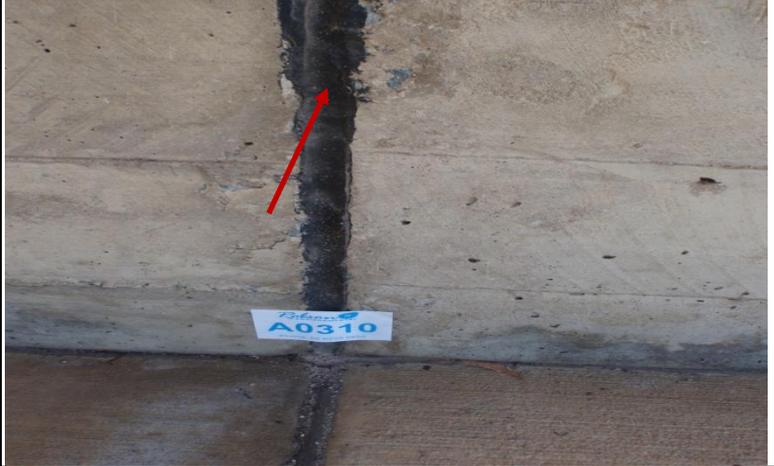
Treloar A			
ITEM NO	ACM TYPE	LOCATIONS	PHOTOGRAPH
14	Mastic	Expansion joints in external walls

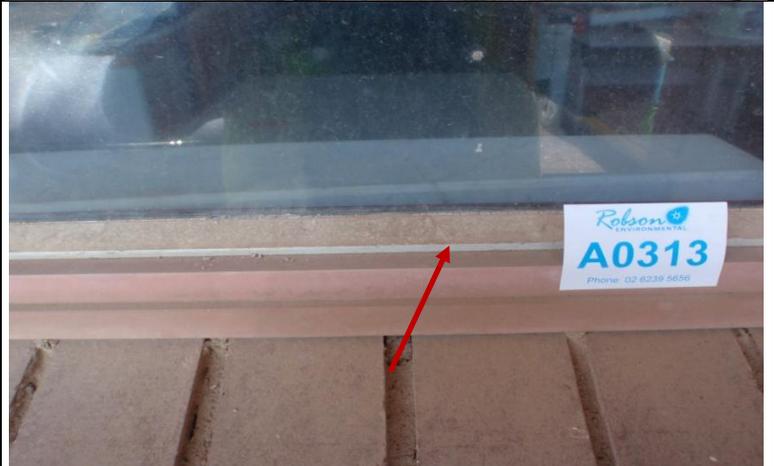
15	Caulking	Building windows

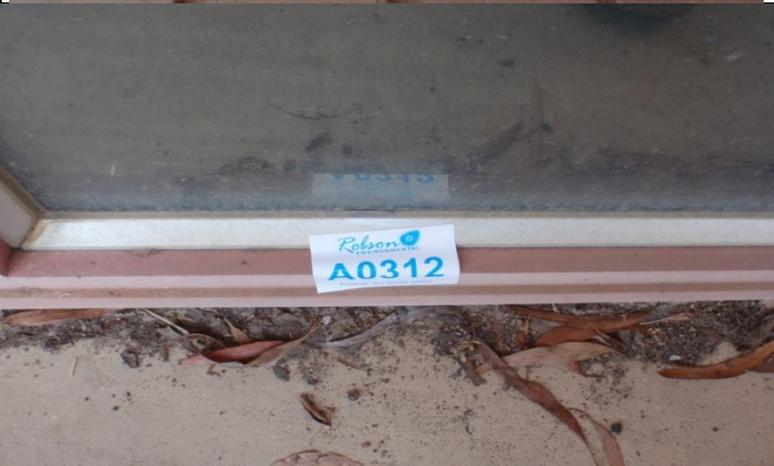
15	Caulking	Building windows

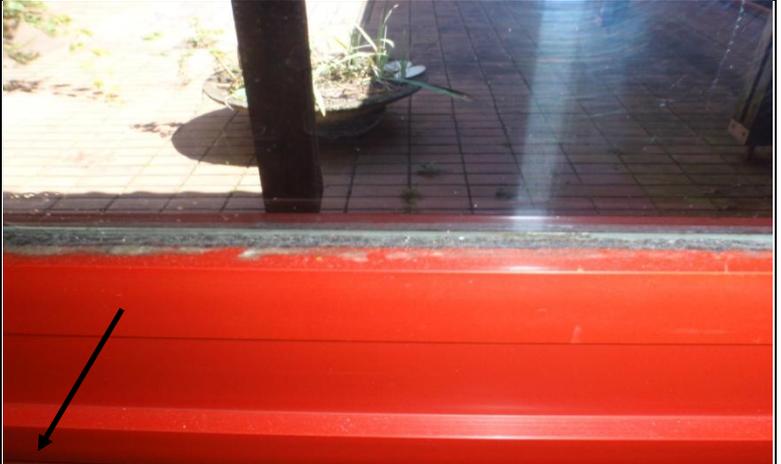
Treloar A			
ITEM NO	ACM TYPE	LOCATIONS	PHOTOGRAPH
18	Black mastic	Metal panels to middle of window frames

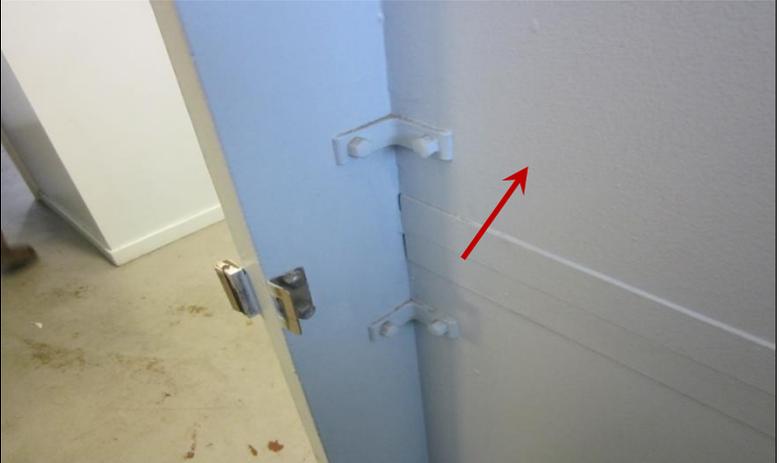
Treloar E			
ITEM NO	ACM TYPE	LOCATIONS	PHOTOGRAPH
19	Sheet	Main building ground floor - Toilet partition

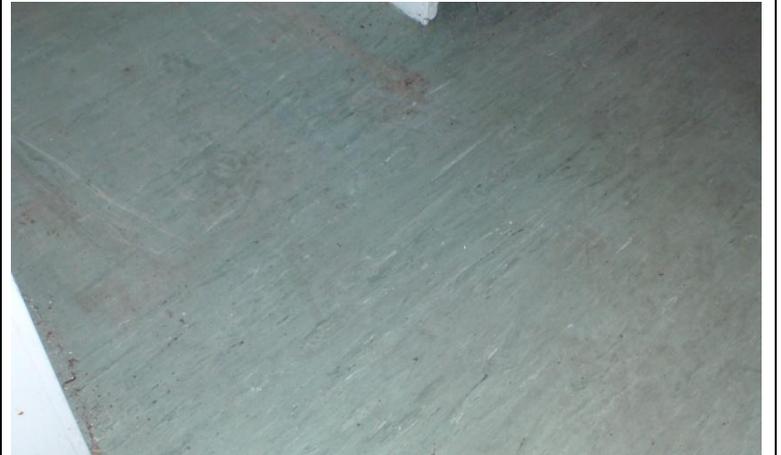
20	VFT	Cream VFT under non asbestos green vinyl

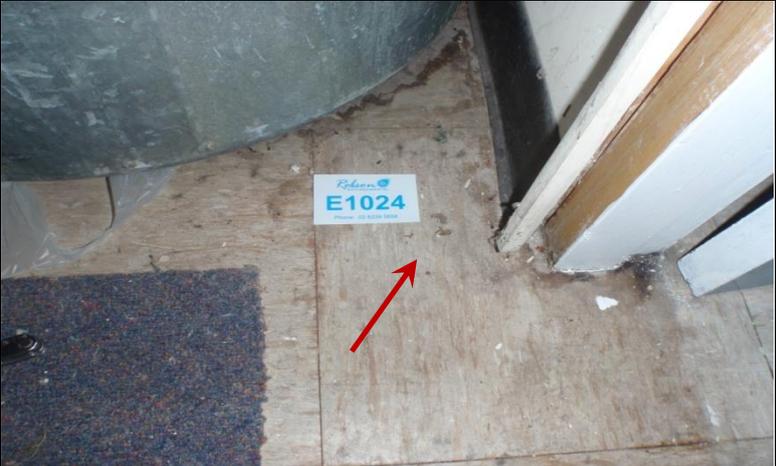
Treloar F			
ITEM NO	ACM TYPE	LOCATIONS	PHOTOGRAPH
21	Beige vinyl floor tile	To floor in hot water system cupboard and toilet area

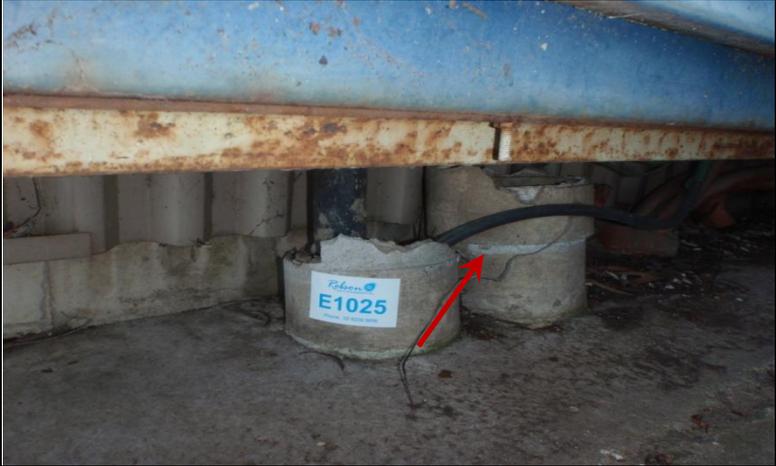
22	Cement pipe	Below distribution board in concrete slab

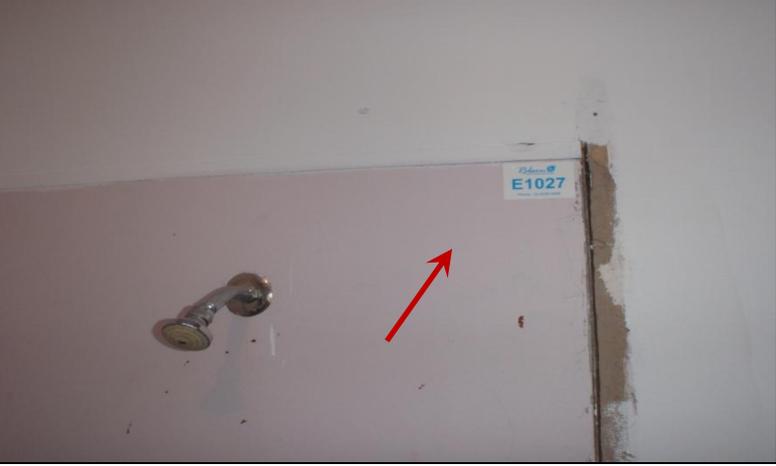
23	Sheet	To wall in shower area embedded in masonry wall of male bathroom

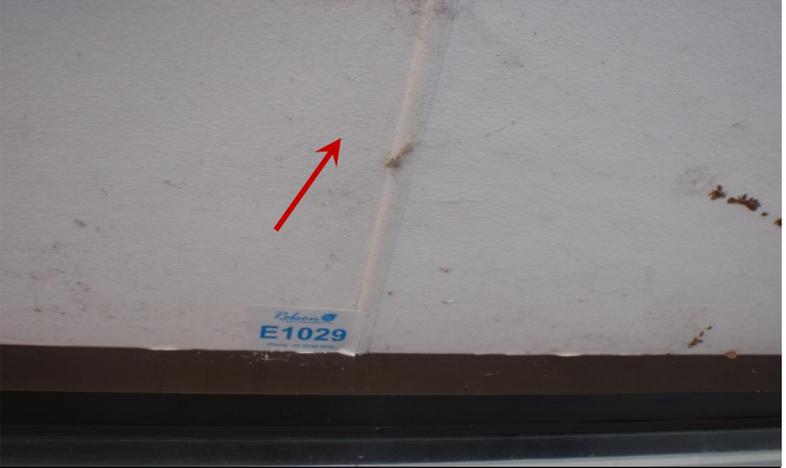
Treloar F			
ITEM NO	ACM TYPE	LOCATIONS	PHOTOGRAPH
24	Sheet	To eaves at front entry to offices

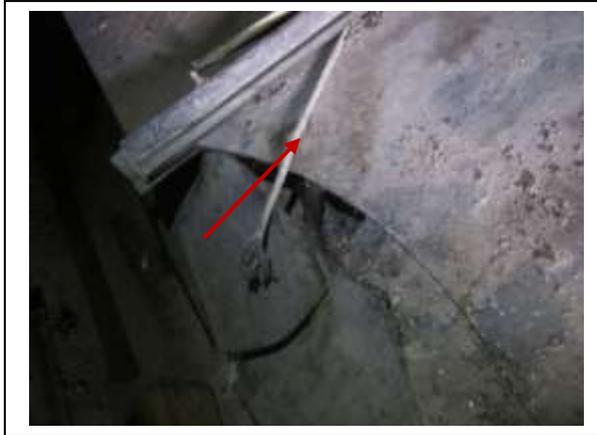
**Photograph 1:**  
Main plant room fire door core  
Cement material  
*Refer Sample: A0530*

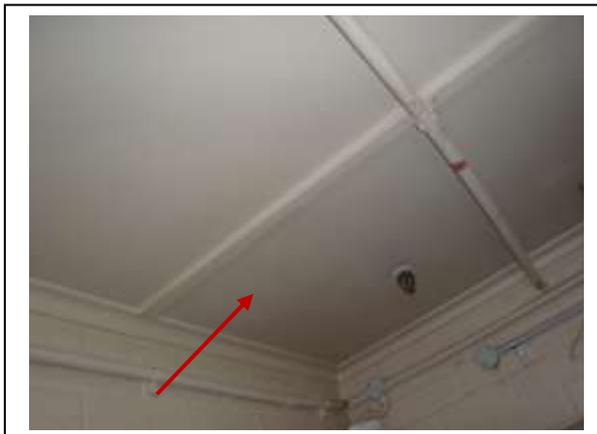
**Photograph 2:**  
Cleaners' rooms ceiling sheet (Main building)  
*Refer Sample: 2719-15*

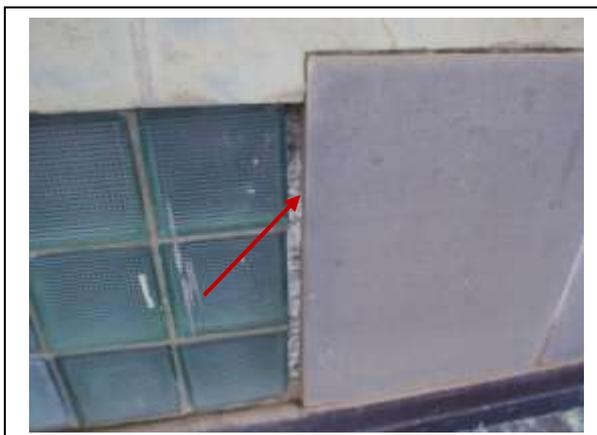
**Photograph 3:**  
AMW - Glass cubes on roof by tower  
at sides - Mastic  
*Refer Sample: A0527*

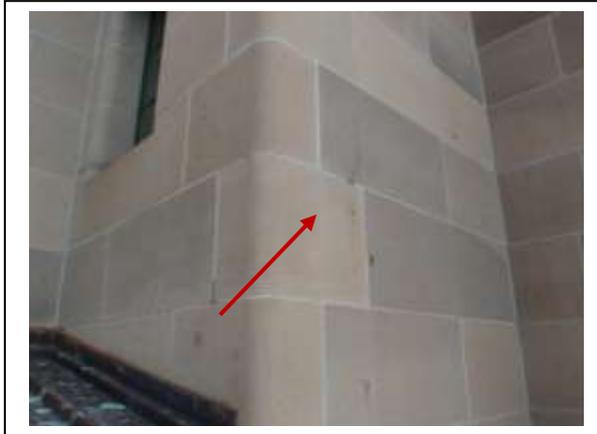
**Photograph 4:**

AWM – To external sandstone block -  
Mastic

*Refer Sample: A0528*

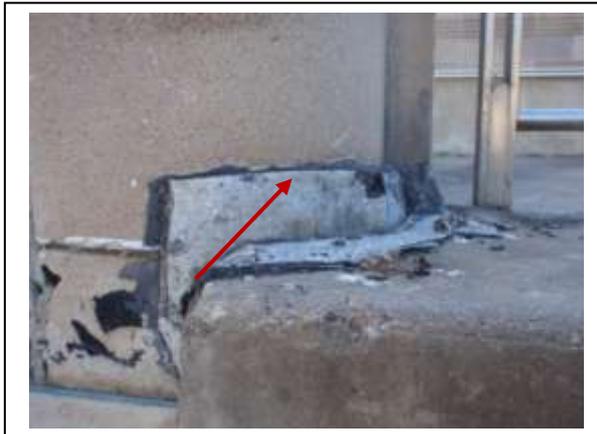
**Photograph 5:**

Adj to external cooling tower plant area  
Bitumen membrane

*Refer Sample: A0531*

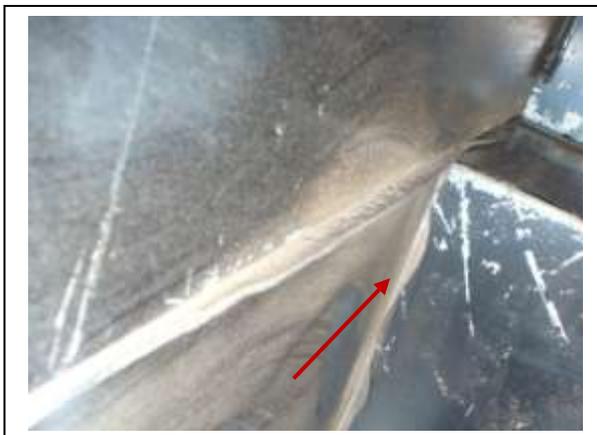
**Photograph 6:**

Main building	12/10/2020	Keane Environmental	12/10/2022	Previously identified A0533	To air handling unit and air conditioning flange joints (3-1) in plant room 3	Mastic	Non friable & good	Chrysotile asbestos detected	Very low	Manage and maintain Inspect Biennially

AHU 3.1 Plant room 3 internal joints  
Mastic

*Refer Sample: A0533*

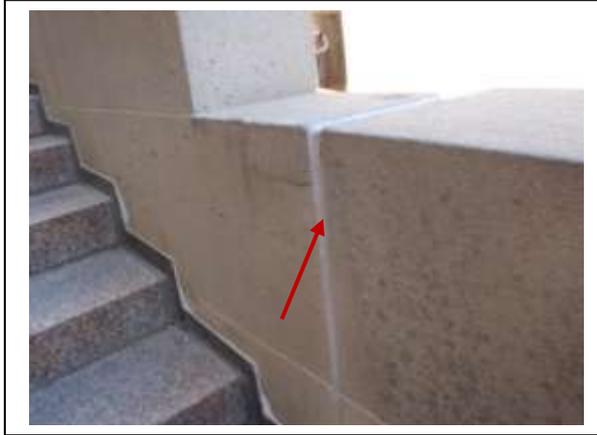
**Photograph 7:**

AWM – Commemorative area steps  
adj main entrance to sandstone block  
Mastic

*Refer Sample: A0609*

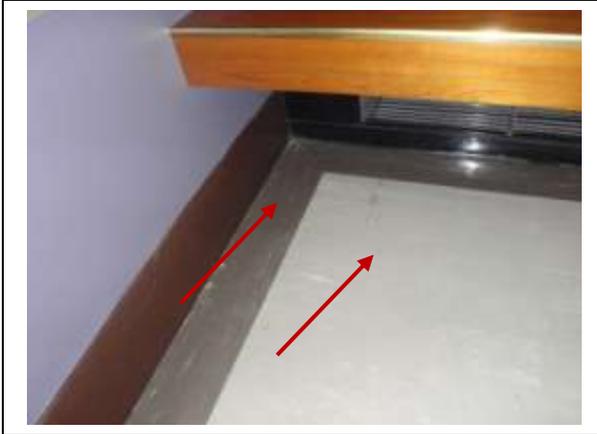
**Photograph 8:**  
Brown & Beige VFT – WW1 Gallery  
*Refer Sample: A0518 & A0519*  
**No asbestos detected**

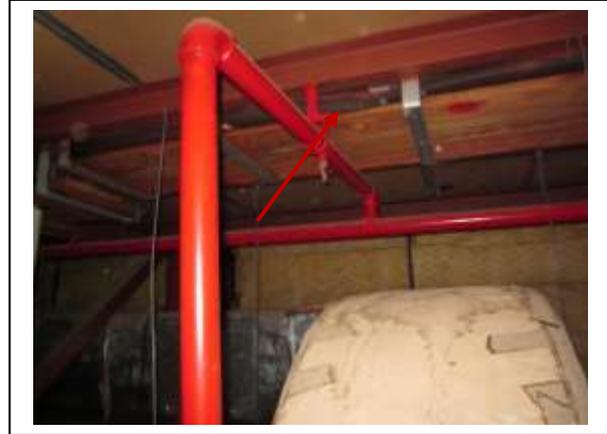
**Photograph 9:**  
In ceiling WW1 gutter  
Bitumen membrane  
*Refer Sample: A0520*  
**No asbestos detected**

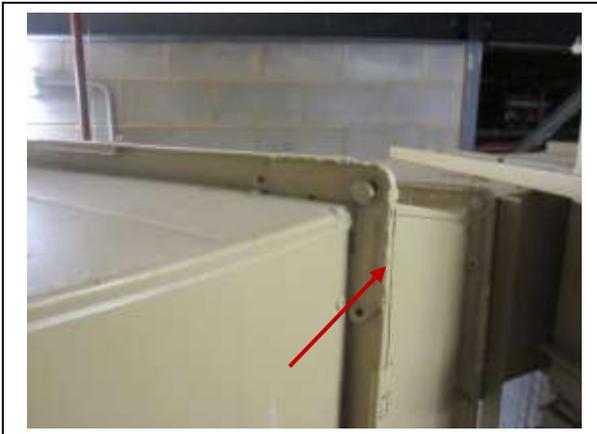
**Photograph 10:**  
WW1 plant room – yellow A/C duct  
work (AHU 12.2) - Mastic  
*Refer Sample: A0521*  
**No asbestos detected**

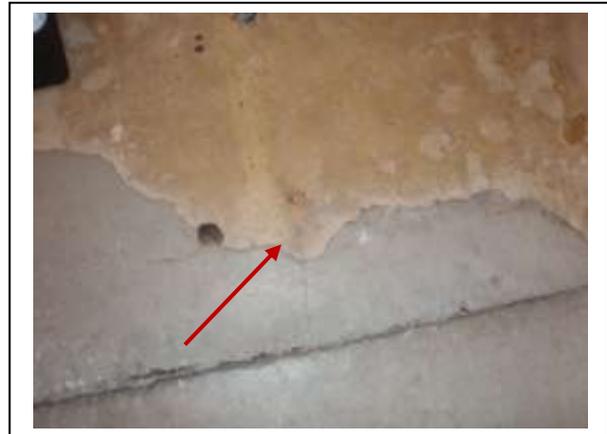
**Photograph 11:**  
WW1 - Plant room 12 access void  
VFC - cream  
*Refer Sample: A0522*  
**No asbestos detected**

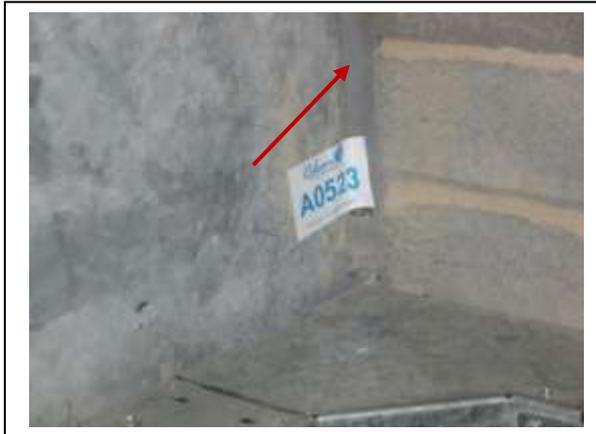
**Photograph 12:**  
Anzac Hall – to expansion joints walls  
and ceiling  
Mastic - grey  
*Refer Sample: A0523*  
**No asbestos detected**

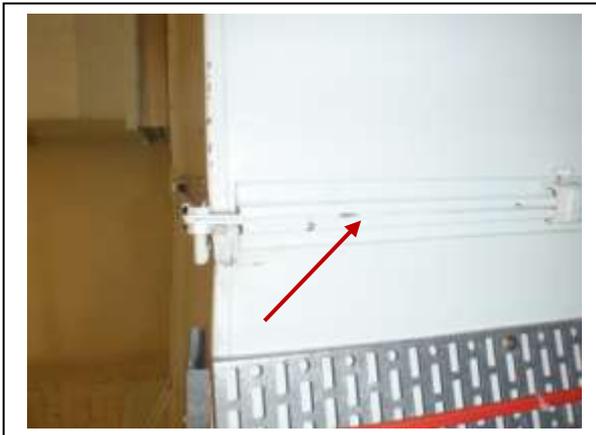
**Photograph 13:**  
Anzac Hall – A/C duct work plant room by  
LMR  
Mastic  
*Refer sample: A0524*  
**No asbestos detected**

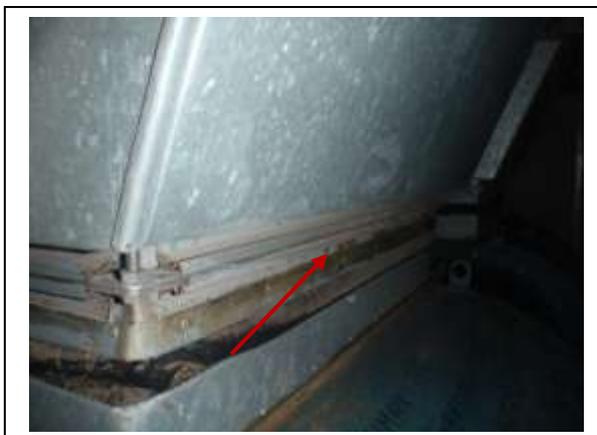
**Photograph 14:**  
AWM – Plant room 9 AHU 9.1 Duct  
Mastic  
*Refer Sample: A0525*  
**No asbestos detected**

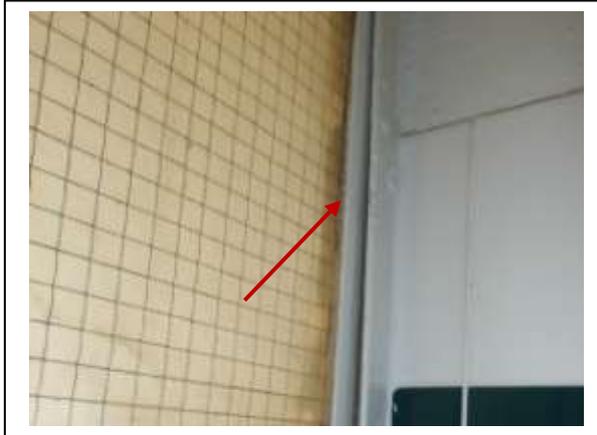
**Photograph 15:**  
AWM – window in male toilet Mastic  
*Refer Sample: A0526*  
**No asbestos detected**

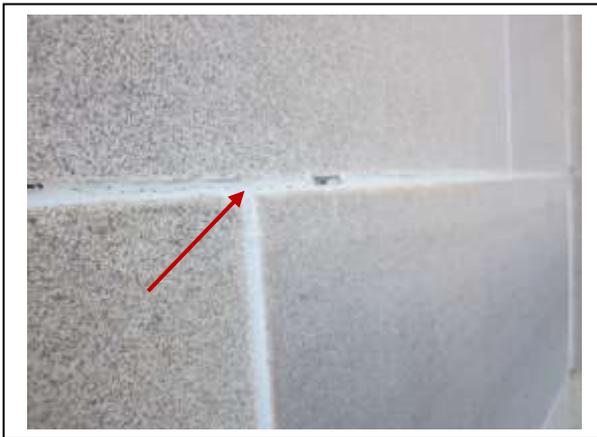
**Photograph 16:**  
AWM – to external sandstone block  
Mastic  
*Refer sample: A0529*  
**No asbestos detected**

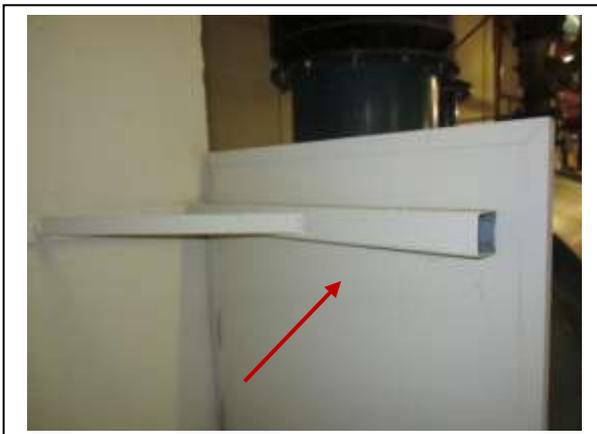
**Photograph 17:**  
Adj rear end of boiler plant room 1  
Sheet  
*Refer sample: A0532*  
**No asbestos detected**

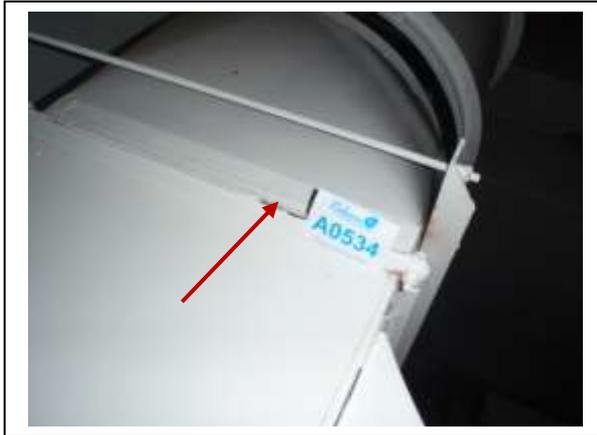
**Photograph 18:**  
AHU 4 Plant room 4 internal joints  
Mastic  
*Refer sample: A0534*  
**No asbestos detected**

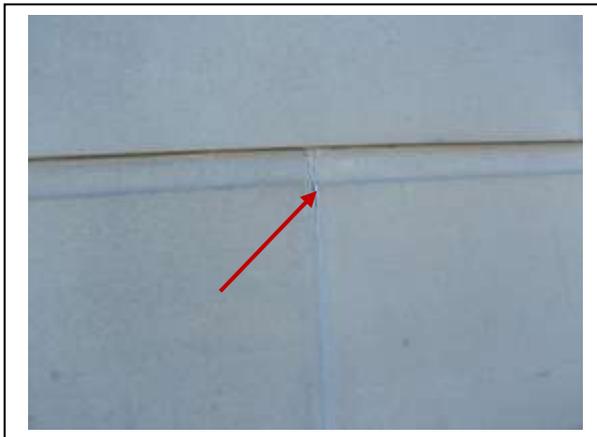
**Photograph 19:**  
West elevation – 1970's extension to  
sandstone block  
Mastic  
*Refer sample: A0610*  
**No asbestos detected**

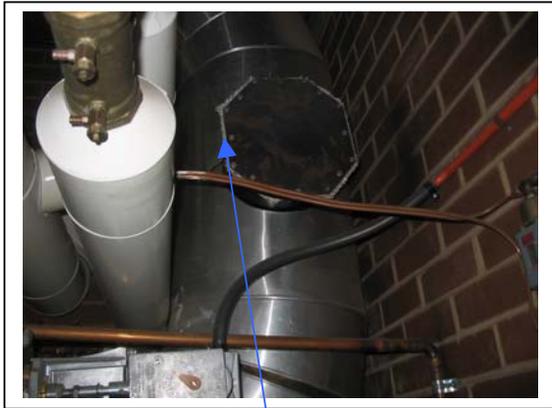
**Photo 1.** Rope lagging to boiler flue.  
(Treloar A)

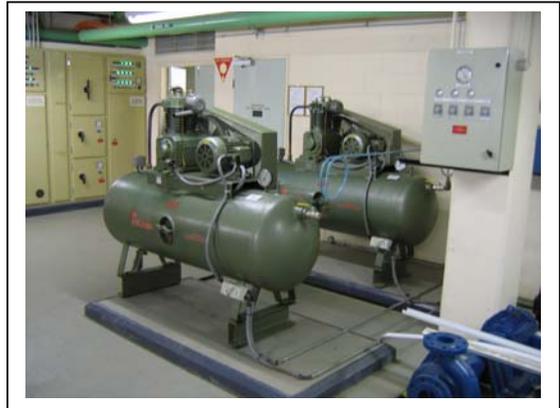
**Photo 2.** Head gaskets on compressors.  
(Administration)

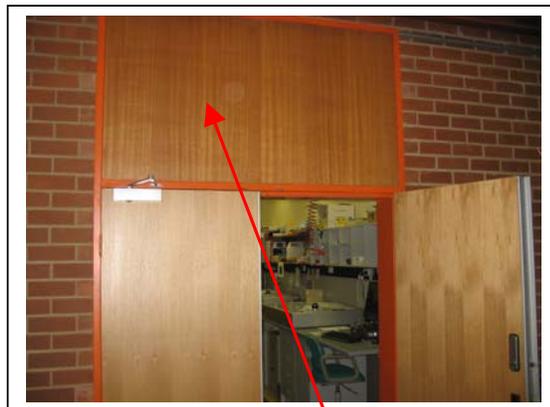
**Photo 3.** Fire doors + possible ACM panels  
within steel frames (Treloar A).
