# ASBESTOS MANAGEMENT PLAN (AMP)

REPORT NO: KE1012 AMP

Australian War Memorial (AWM)

Treloar Crescent, Campbell ACT 2612

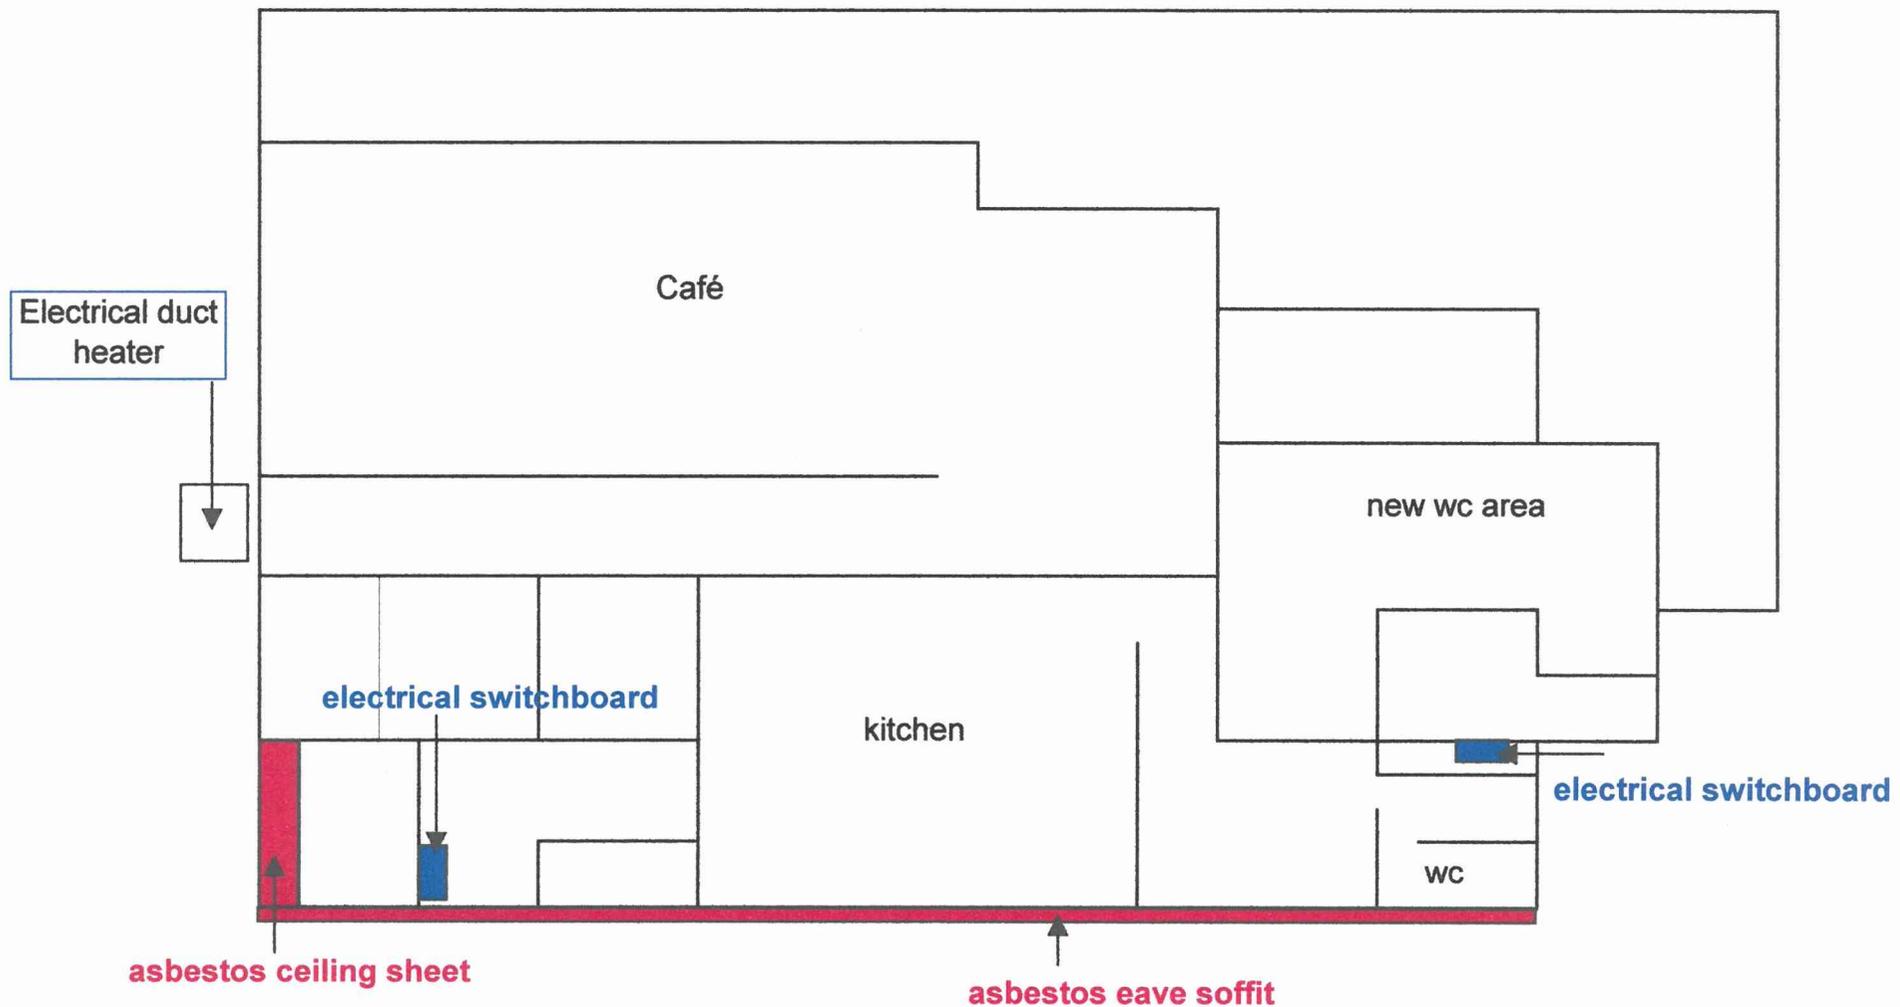
## Australian War Memorial - Outpost Café Asbestos Materials

<b>Sample No.</b>	<b>Location – Outpost Café</b>	<b>Composition</b>
1906 – 01	Serving area vinyl floor tiles (beige)	no asbestos detected
1906 – 02	Café area vinyl floor tiles (brown)	no asbestos detected
<b>1906 – 03</b>	<b>Staff wc area – switchboard sheet</b>	<b>Chrysotile asbestos</b>
<b>1906 – 04</b>	<b>Rear eaves soffit sheet (old)</b>	<b>Chrysotile asbestos</b>
1906 – 05	Front eaves soffit sheet (new)	no asbestos detected
<b>1906 – 06</b>	<b>Moulded inground PMG box</b>	<b>Chrysotile &amp; amosite asbestos</b>
<b>1906 – 07</b>	<b>Exterior alcove ceiling sheet Visually consistent with 1906 - 04</b>	<b>Chrysotile asbestos</b>
1906 – 08	Drinks storage area wall sheet	no asbestos detected
1906 – 09	Caulking to front column	no asbestos detected
